Town of Washington Grove
Stormwater Management Assessment
Date August 23, 2023

**Prepared For: Town of Washington Grove
300 Grove Ave Washington Grove MD**

WASHINGTON GROVE EAST STREAM ASSESSMENT AND RECOMMENDATIONS

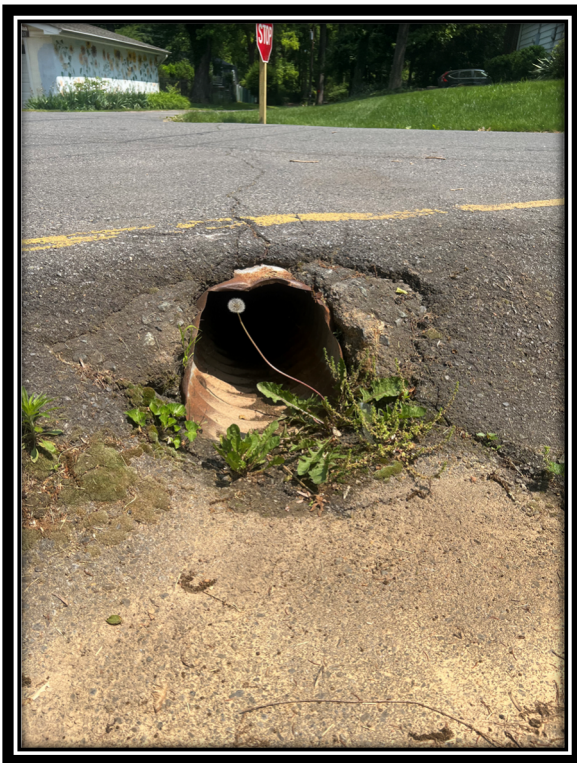
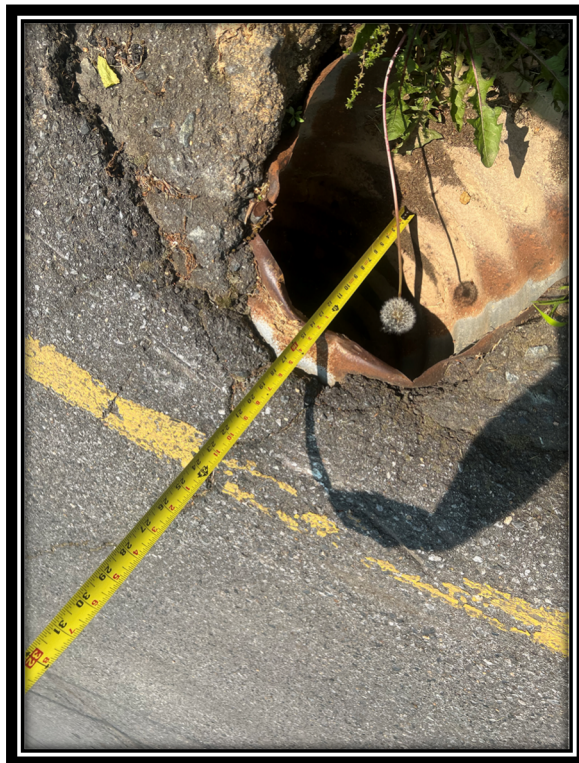
The existing storm infrastructure at Washington grove is in need of maintenance, repair and in some cases replacement. The existing infrastructure appears to be undersized, cluttered and rusted through. As Shown in Figure 1 the existing road conveyance pipes are undersized and made of old material.

Figure 1. Undersized CMP.

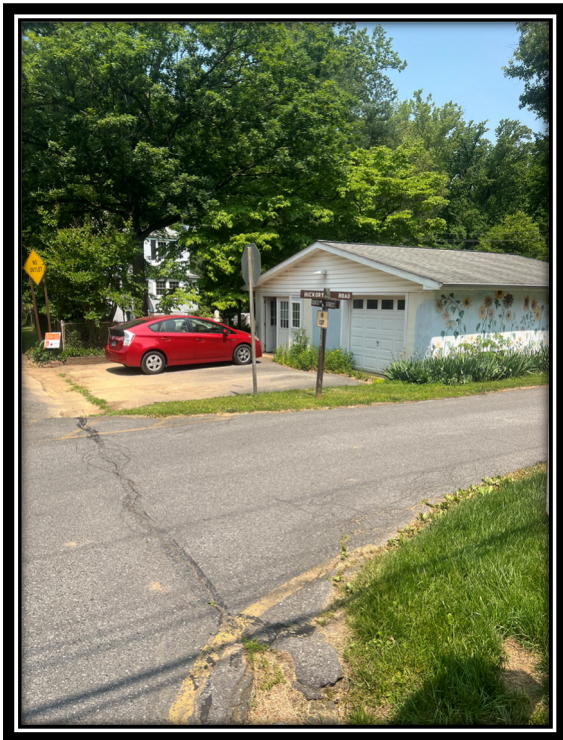
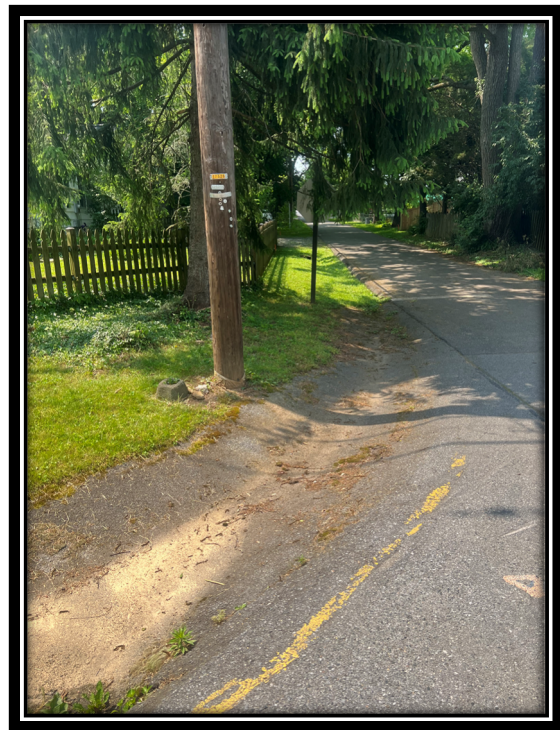
As Shown in Figure 2, the asphalt swales on the side of the roads provide no infiltration are old and a drainage analysis needs to be done to see if they are adequately sized. Many of the inlets onsite are inefficient, undersized, and filled with clogging debris. As Figure 3 shows some of the structures are buried and others are just too small.

Figure 2. Asphalt swales need to be replaced with bio swales to treat water before it hits storm drain and reaches West Woods.

Having bioswales at the locations of the asphalt swales would encourage infiltration and reduce the amount of runoff that is delivered to West Woods. A soils investigation is needed to determine the effectiveness of these devices however any amount of infiltration will enhance the capabilities of the system. The increase in infiltration will reduce stormwater runoff and reduce erosive flows in the west woods stream. The larger swale section will convey a larger volume of water and route it through a system that will control the flow so that it does not erode out the stream in west woods. The increased size in bioswales can be accomplished through grading within public right of way, minor roadway width reduction and grading easements from adjacent property owners.

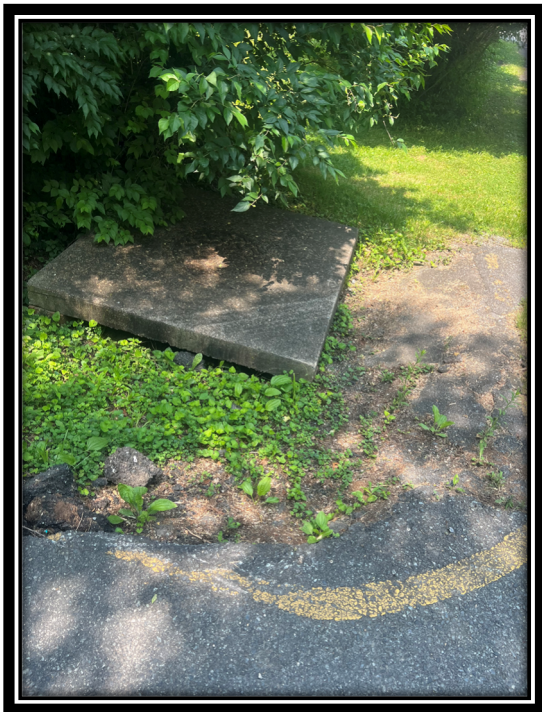
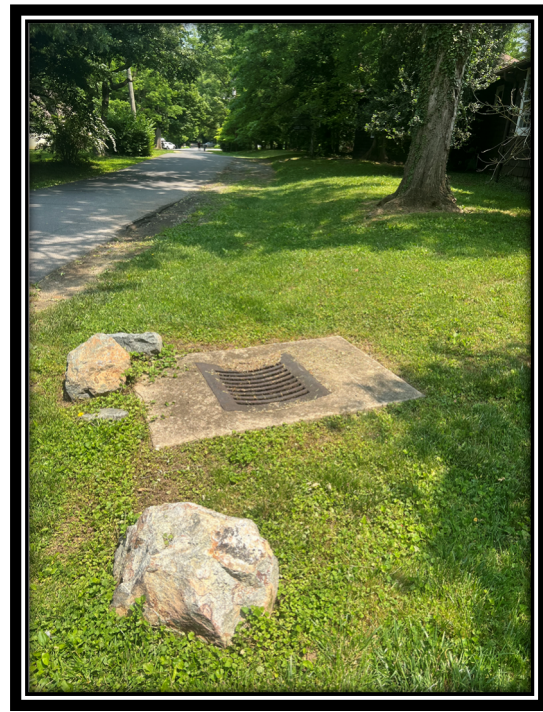
Figure 3. Varying types of structures onsite could be replaced with more efficient structures that can handle a larger capacity and further prevent overland flow from bypassing structure and creating runoff in west woods.

Soltesz observed Storm Drain structures on site that if replaced with more efficiently designed structures that incorporate more modern technology would increase inlet capacity and reduce bypass and sump ponding at inlets. This increase in capacity would route the water to ESD devices that would reduce direct runoff from being delivered to the West woods. In addition easements could be placed onsite to prevent the current stable flow paths from being disrupted. The design rule of thumb from the County manual states that when flow exceeds 2.5 acres, 3 cfs or after flow crosses a third property line a surface drainage easement is required. This would decrease the chance of someone building something on their property that will obstruct the flow path and reduce the chances of erosion or flooding.

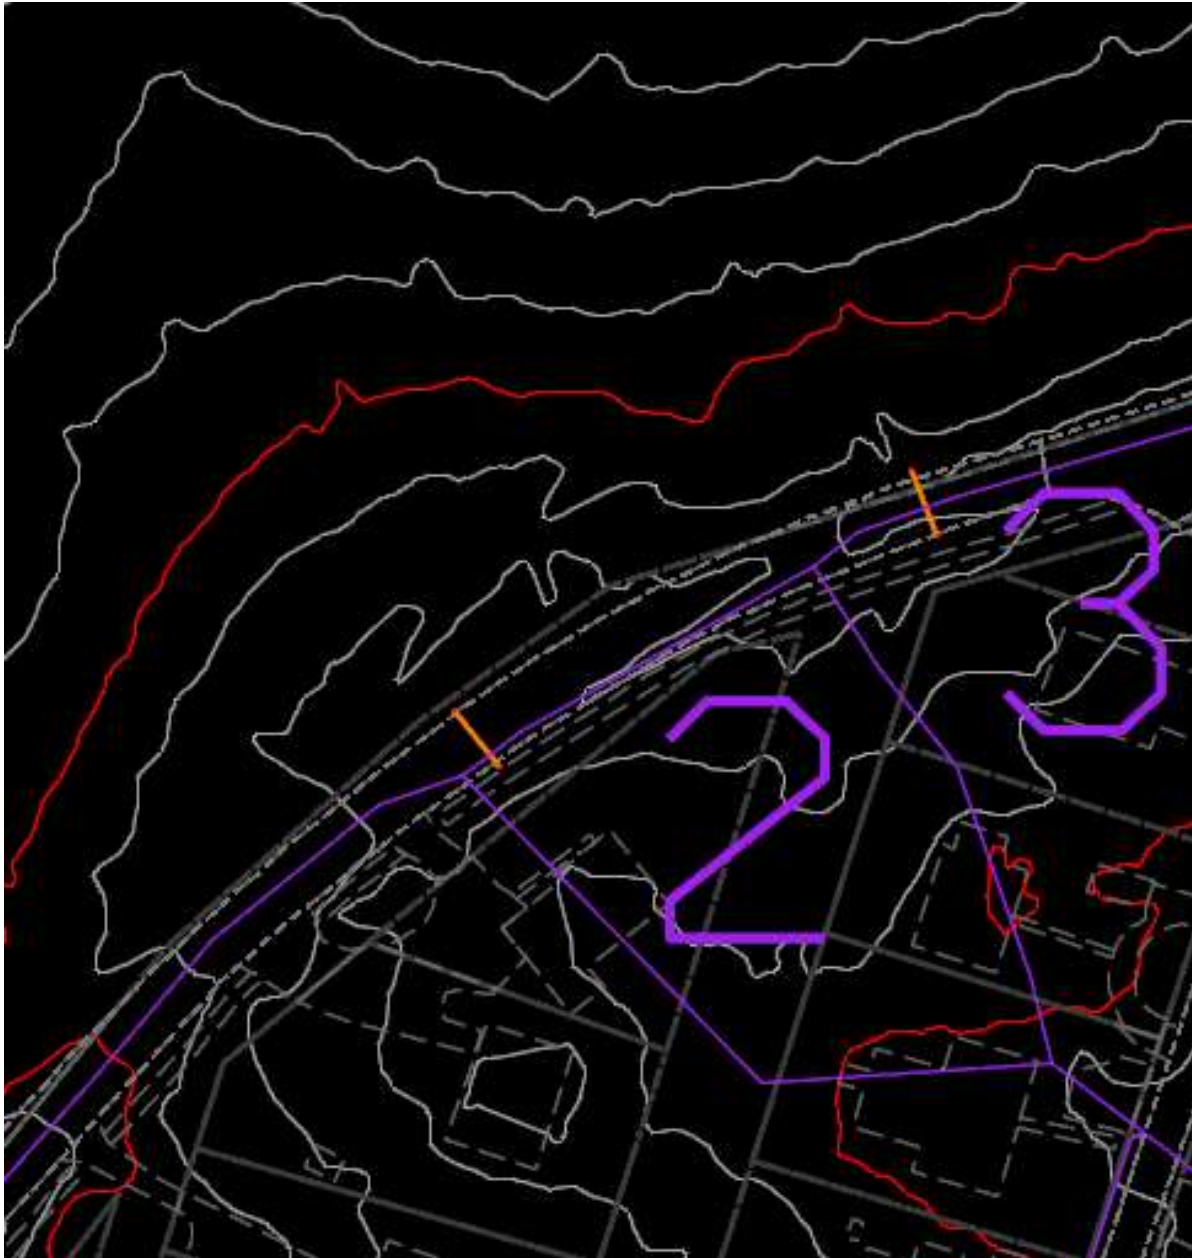
SD in place unable to be identified assumed to be CMP

*Could not be found in field or via google maps

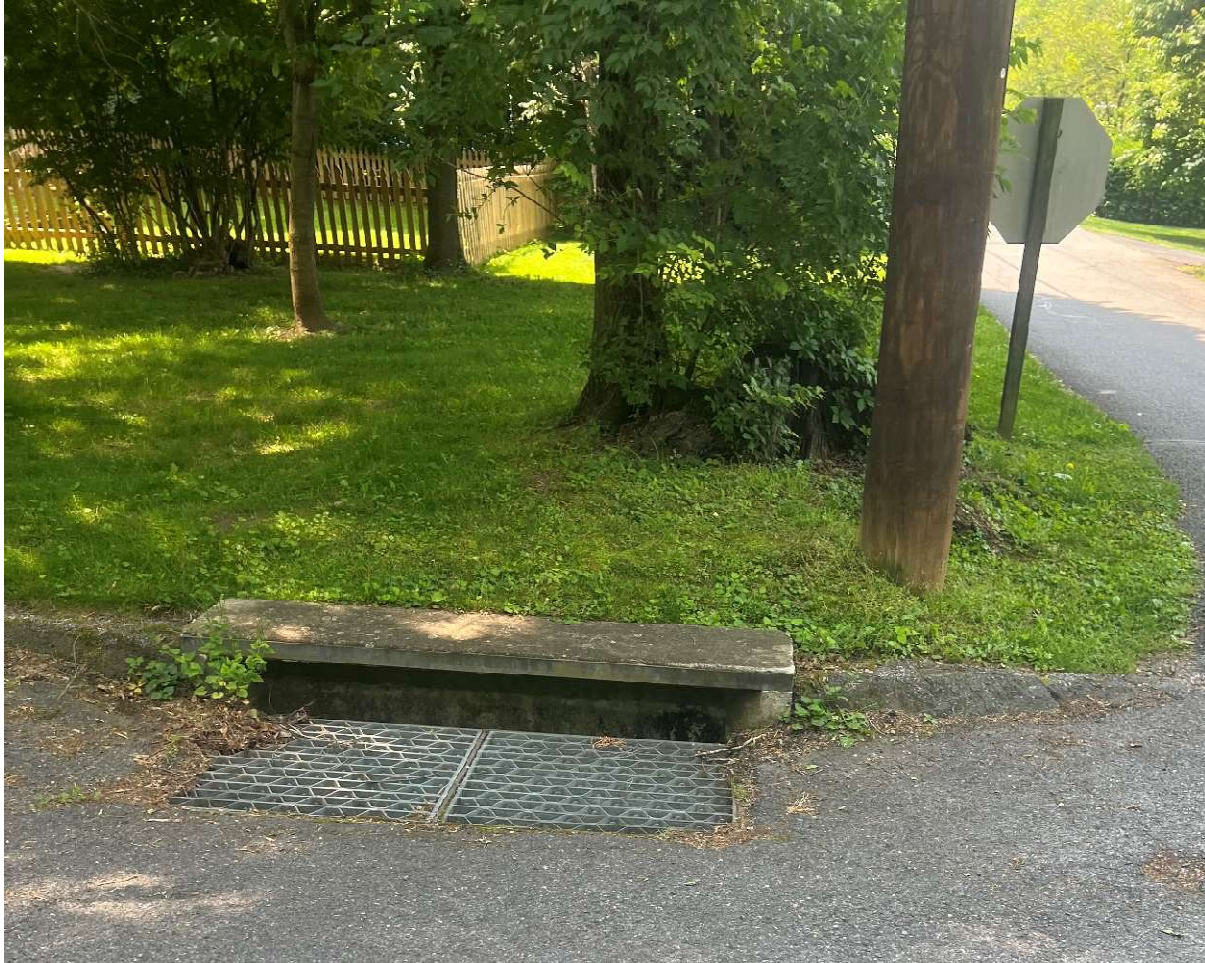
South East corner of the intersection – Good condition

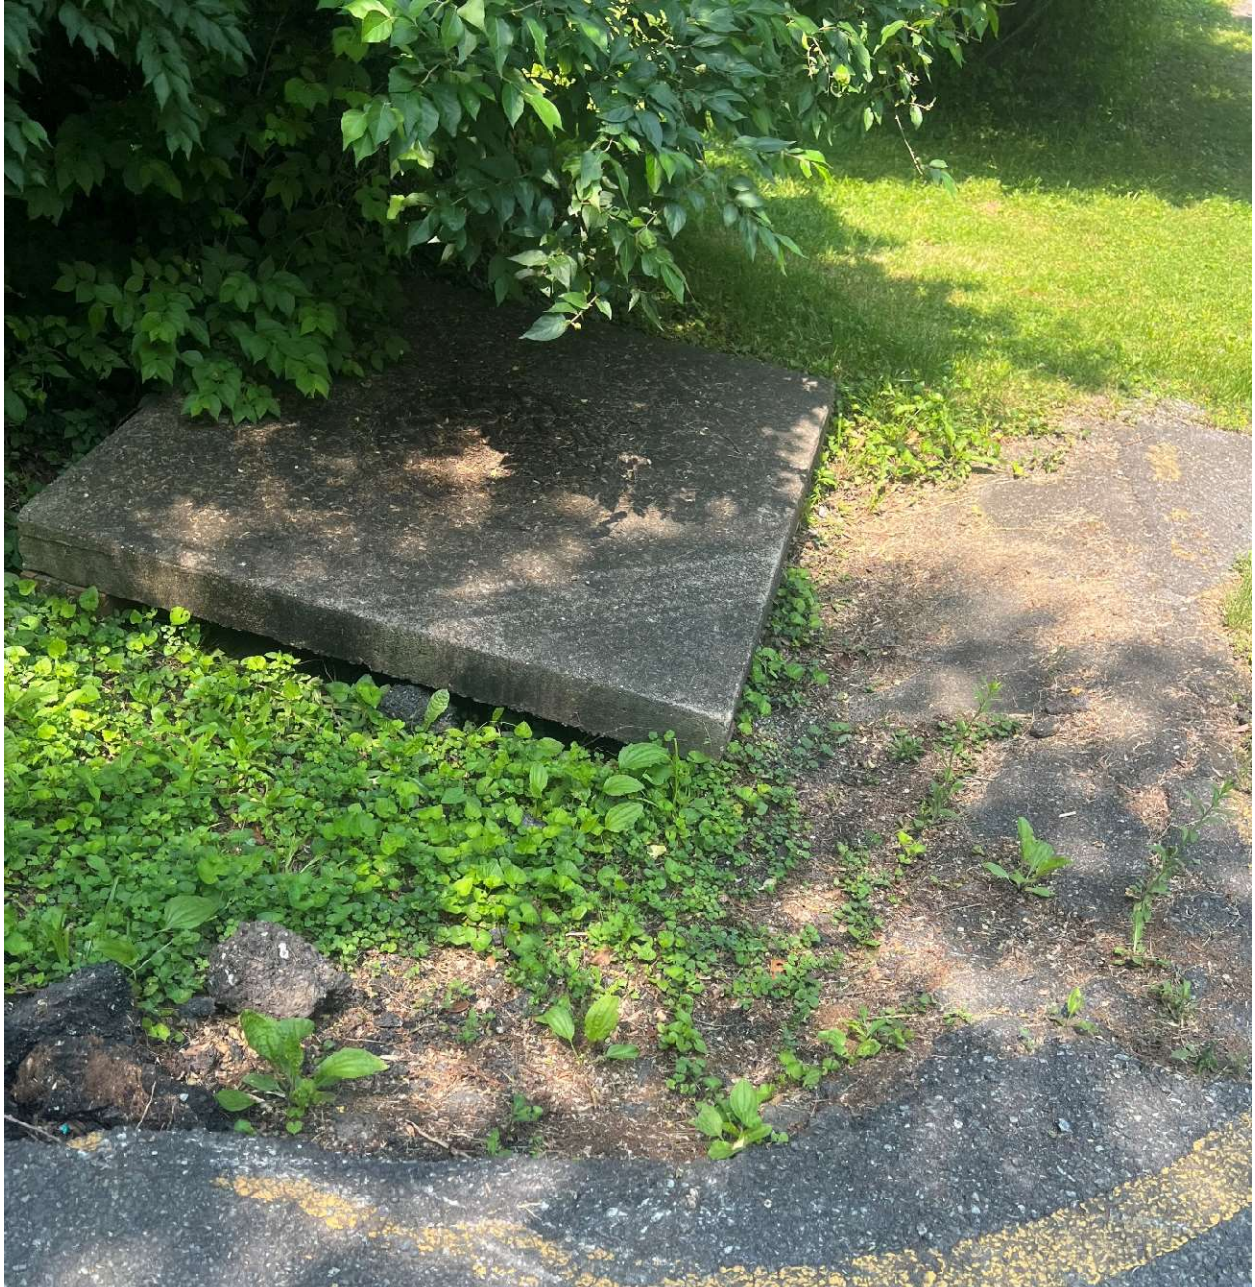
Southwest corner of the intersection – Could be cleaned up a little

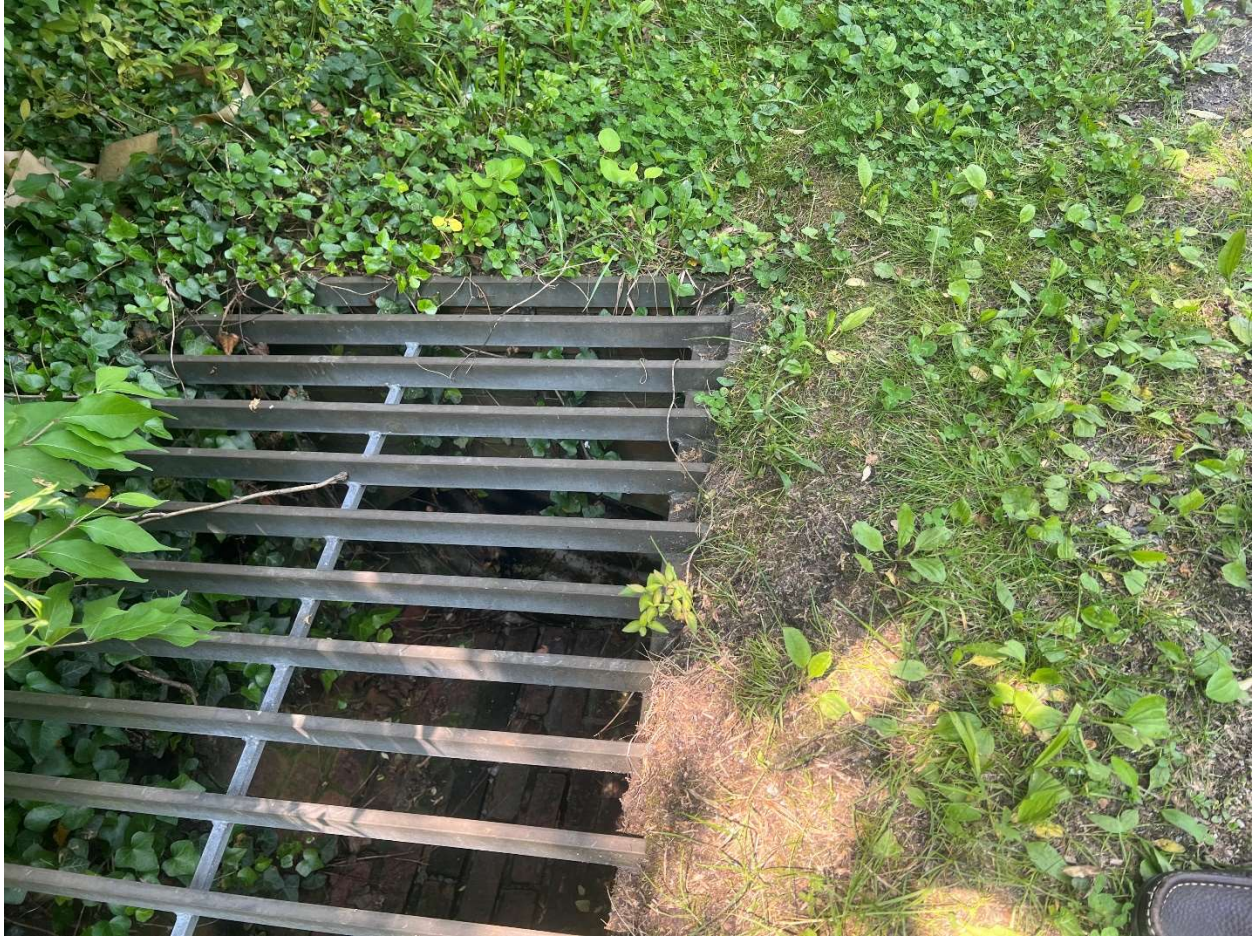
24" SD in place good condition – further down Oak Street

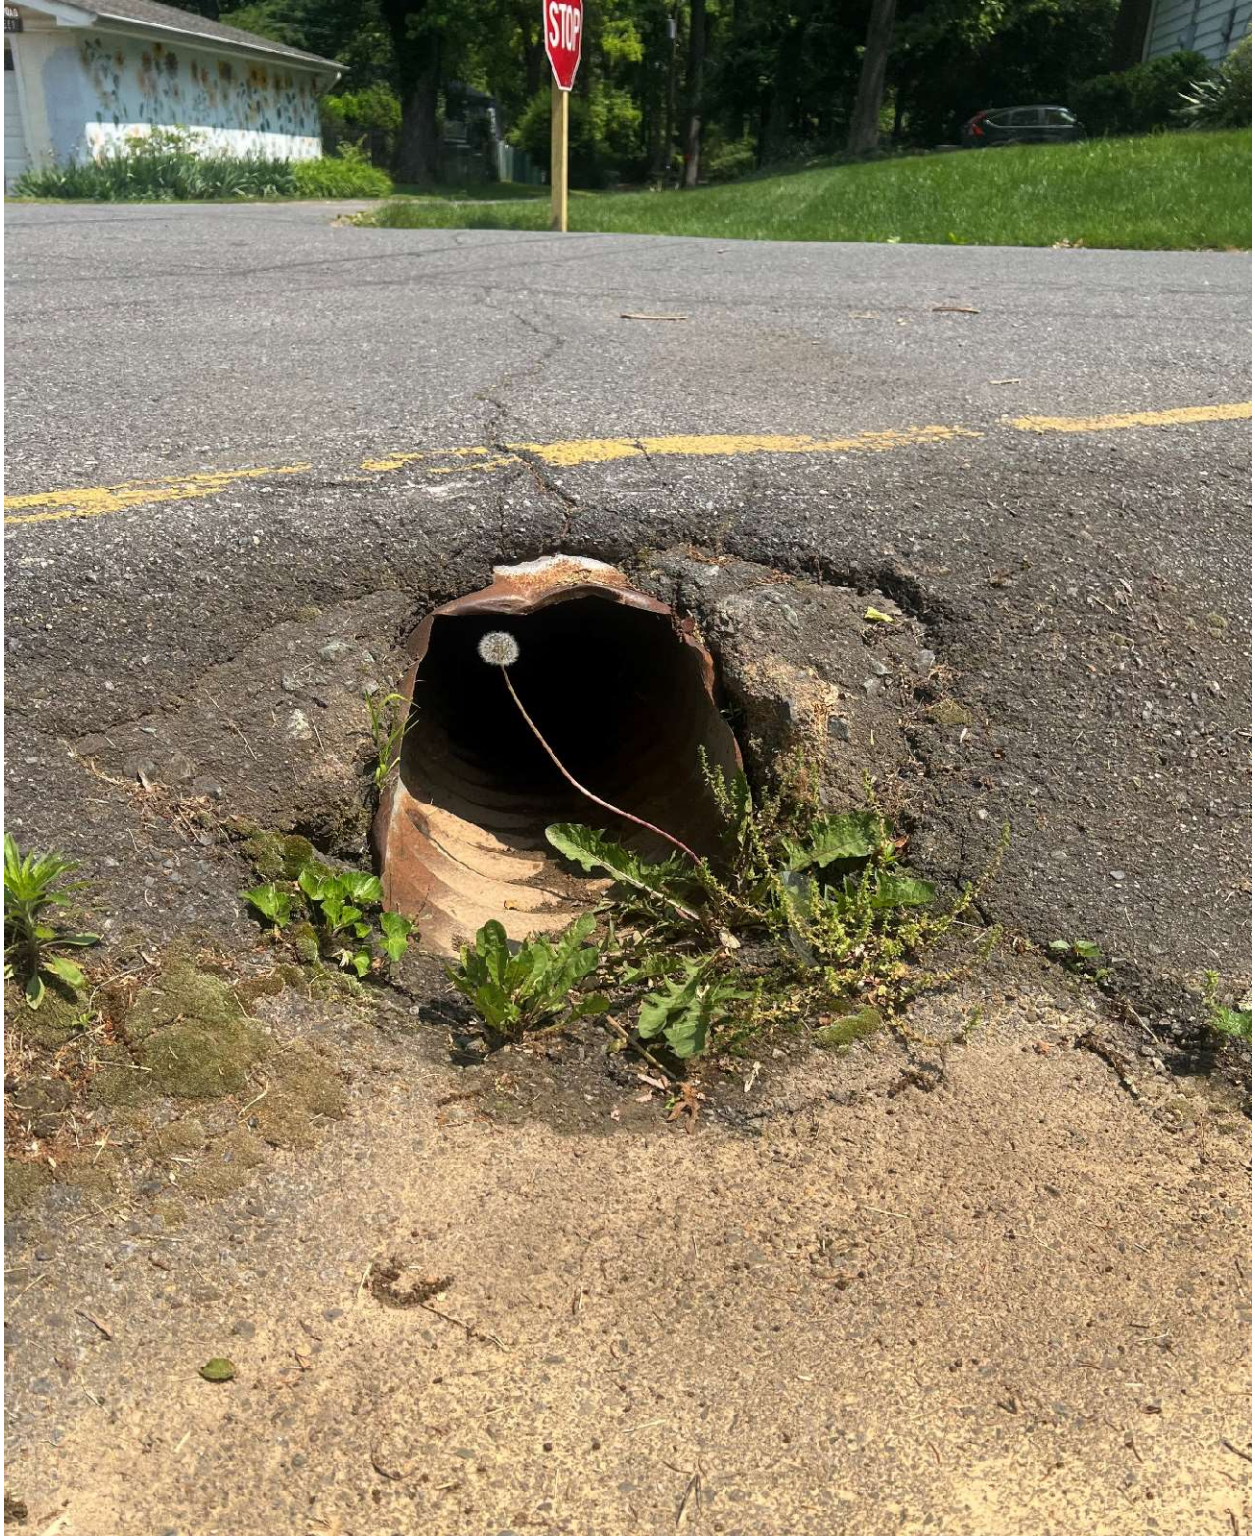
Invert In at Hickory and Center Street – Good condition

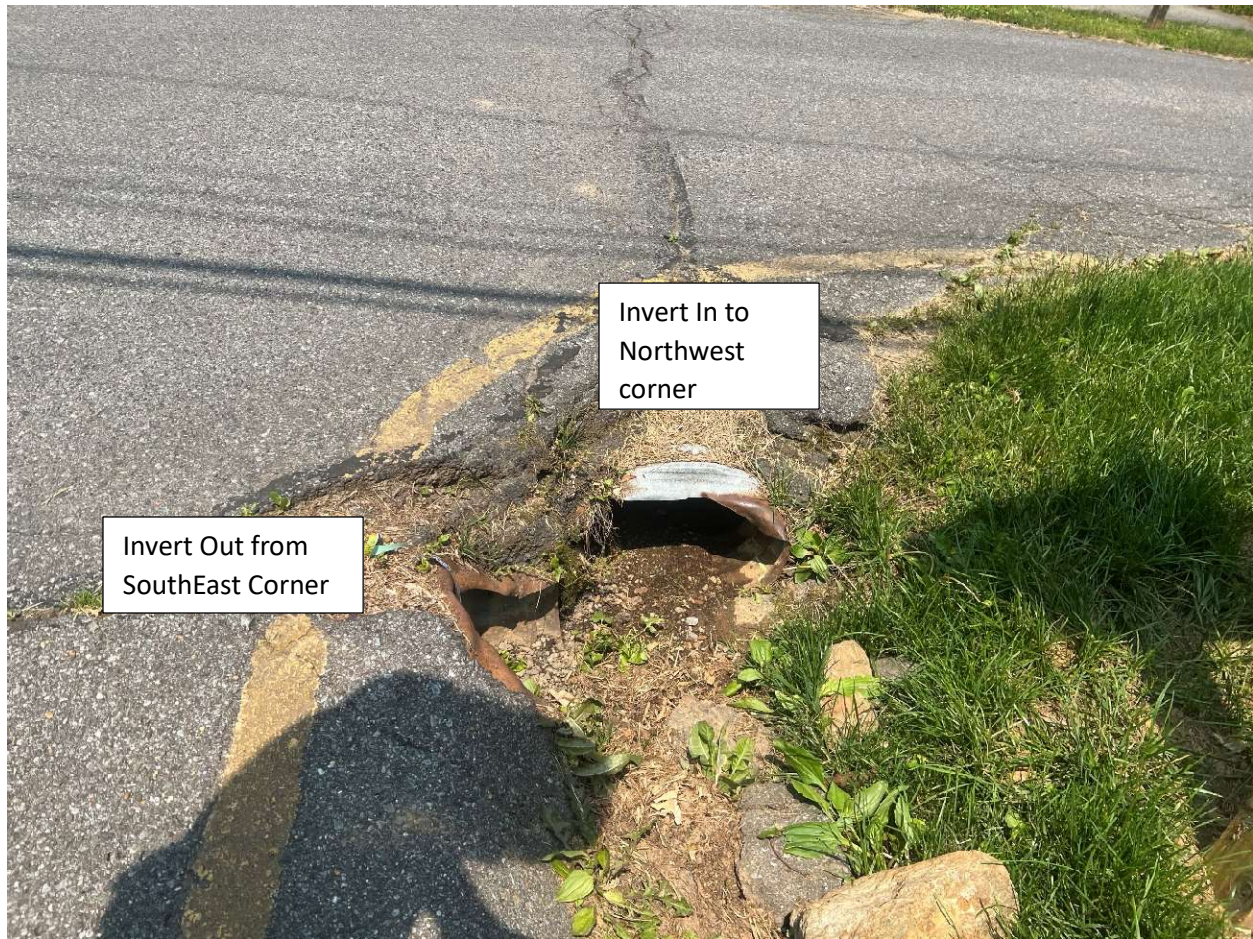
NorthEast Corner of Hickory Road and Center Street Intersection

Condition of SD – Poor clogged

The structures that were observed to be clogged with debris and filled in will need to be cleaned out. Some structures will be filled in worse than others with some needing to be unburied after years of being heavily filled in.

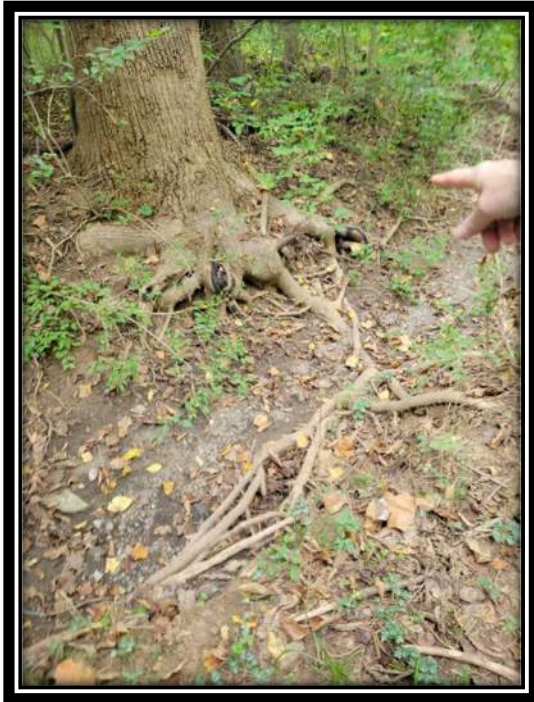
Figure 3. Erosion downstream of outfall. Although mild the residents have noticed a widening and deepening of the channel in this intermittent ditch.

Roughly, 100 feet downstream of the outfall from Washington Grove Lane there is evidence that the flow regime has changed and the incipience of down cutting and lateral widening is observed.

Figures 3 and 4 both show that where there was once vegetation downstream of the outfall from the community, and shallow concentration flow conditions has now evolved into a channel flow regime that is carving out a trapezoidal channel of dimensions witnessed in the photos above. The bare channel bottom and side slopes show where the highest velocity flow is during the lower frequency storms have removed finer sediment and have eroded to the more coarse gravel and cobbles sub-layers and confining elements such as surface protection from tree roots.

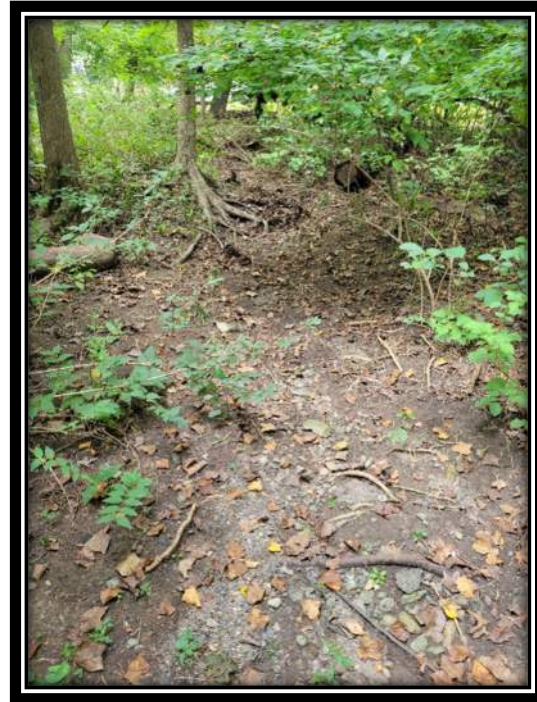
Figure 4. Area that once was covered in vegetation now showing evidence of erosive velocities due to channeling that can not sustain vegetation on the banks.

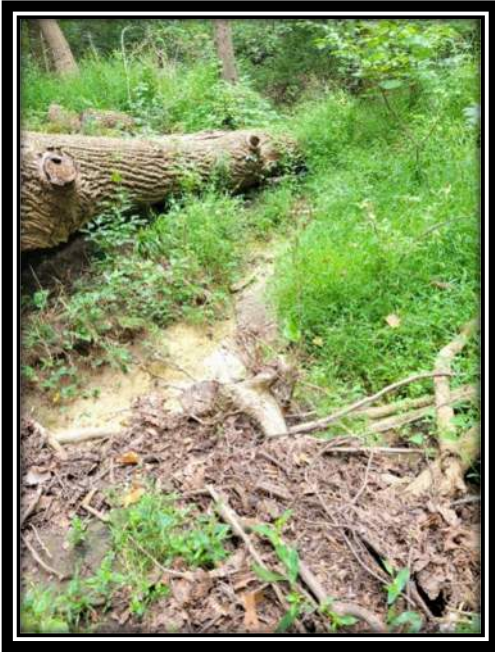
Moving downstream from the outfall this channel reaches a confluence with another channel that shows the beginning of more severe erosion. What appears to be holding the channel in place are logs and dense meadow vegetation as shown in Figures 5 and 6.

Figure 5. Channel further eroding due to increased runoff from community.

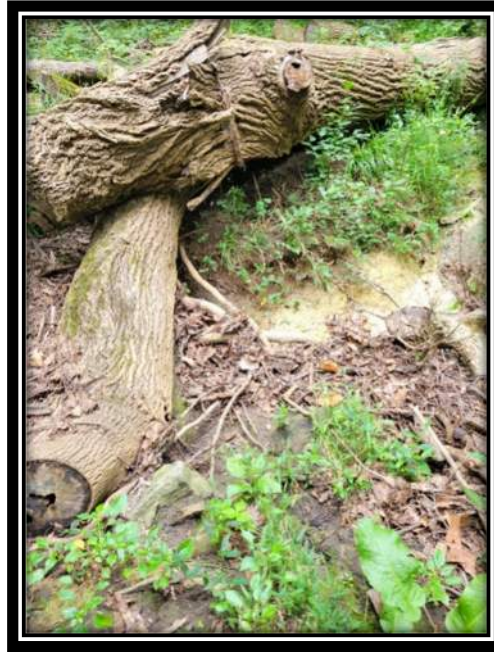
Figure 6. Channel erosion being mitigated by log that has been placed as a natural checkdam.

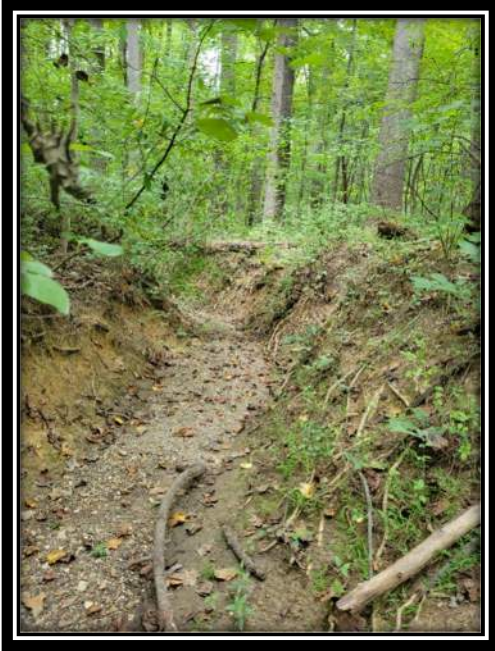
Figure 7. Channel further downstream has high indices for bank erosion hazard. Exposed bare soil with steep angles is a recipe for erosion and evidence that it has occurred.

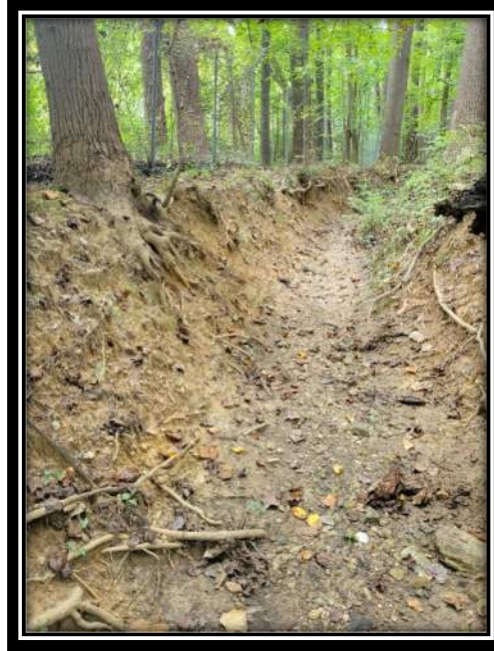
Figure 8. Tree roots provide protection for the stream on the top of bank however it is only a matter of time before they are undercut and fall into the stream. Disconnection from the channel means lower water table which means the trees have less access to water.

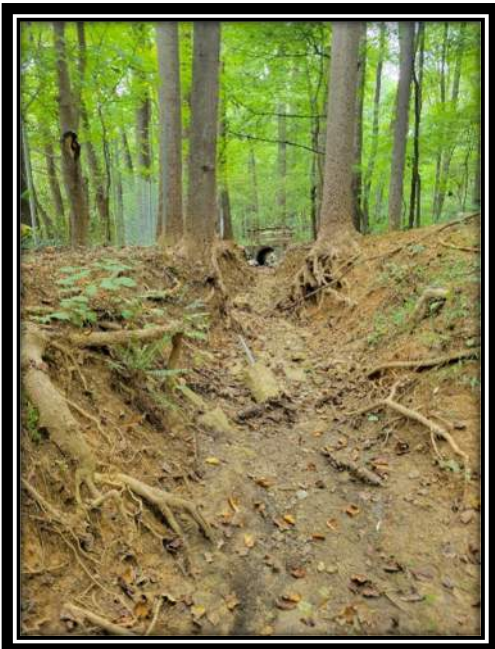
Figure 9. Channel with minimal hindrance to erosion and severe entrenchment causing all flood flows to be contained in the channel and increase pressure on the banks.

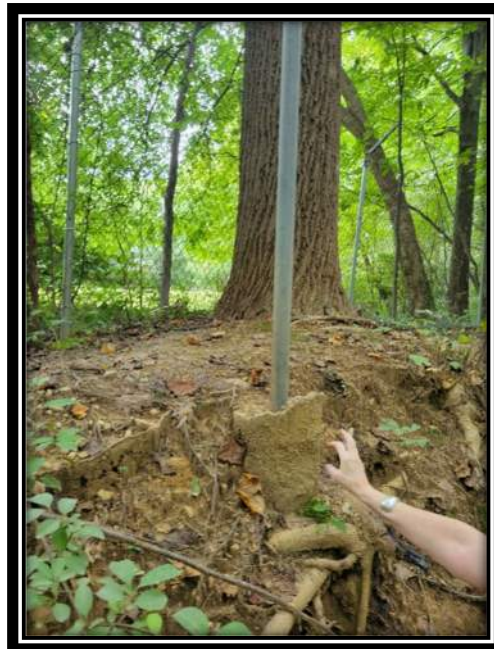
Figure 10. Fence post shown about to fall in channel. Also new fence can be seen in background that was installed due to threat of theft of aeration equipment for Maple Lake.

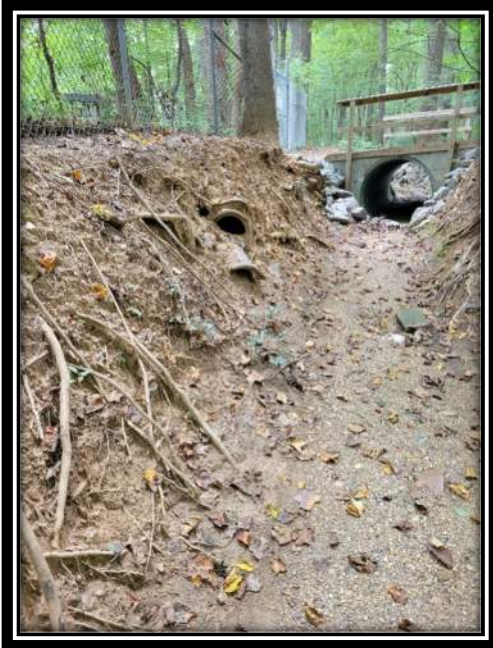
Figure 11. Apparently abandoned utility line that once had cover is now exposed and contributing to channel bank protection. Cast in place culvert after old undersized pipes were removed.

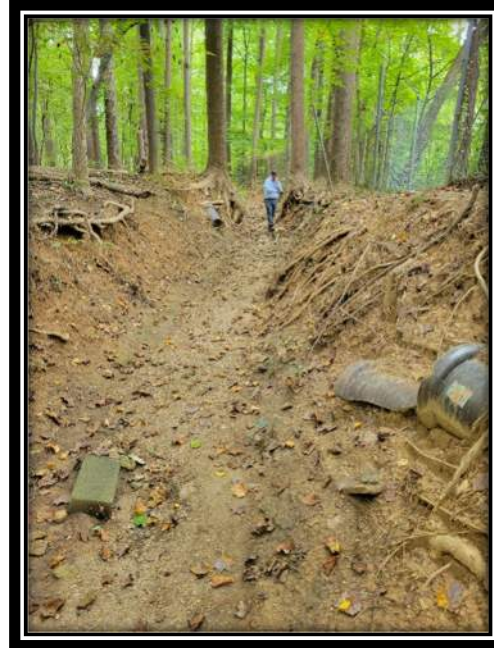
Figure 12. Looking upstream seeing where fence was replaced. Multiple pipes and fence replacement show that besides impact to the environment this erosion is creating big expense for the towns infrastructure.

The accelerating vertical erosion appears to be creating an exorbitant cost for the community of Washington Grove. The failing culverts, fences and pipes are completely preventable and could be lessened. It is costing them both time, man power, and resources to keep up with this worsening problem.

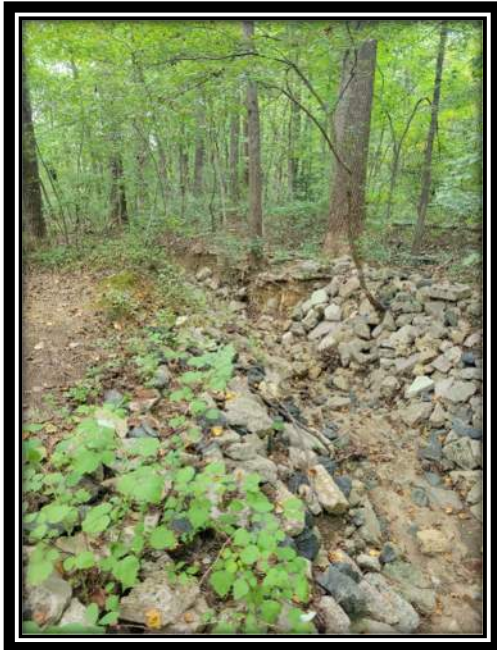
Culvert on both the upstream and downstream ends have been heavily armored with rip-rap, and it is apparent from Figures 13 and 14 that this is mitigating the erosion. Once the rip-rap ends it can be seen that erosion commences with steep bank angles, bank undercutting, and trees that are on the edge of falling into the channel. This measure only appears to be working in a temporary condition because with the aforementioned erosion at the interface of the revetment that will cause the soil both under and to the sides of the rip-rap to fail which will lead to rip-rap scattering in the channel downstream.

Figure 13. Looking downstream of the Culvert. Trees are compromised right at the downstream limits of rip-rap armoring.

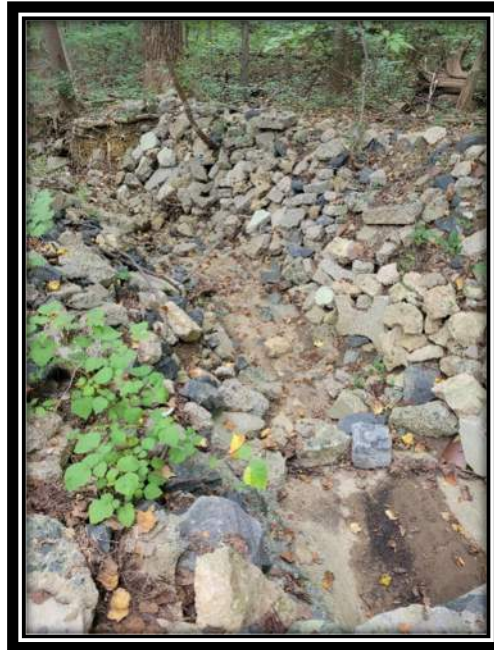
Figure 14. Channel downstream of culvert has been temporarily fixed with rip-rap however there is a risk of losing this rip-rap due to increased energy just below revetment.

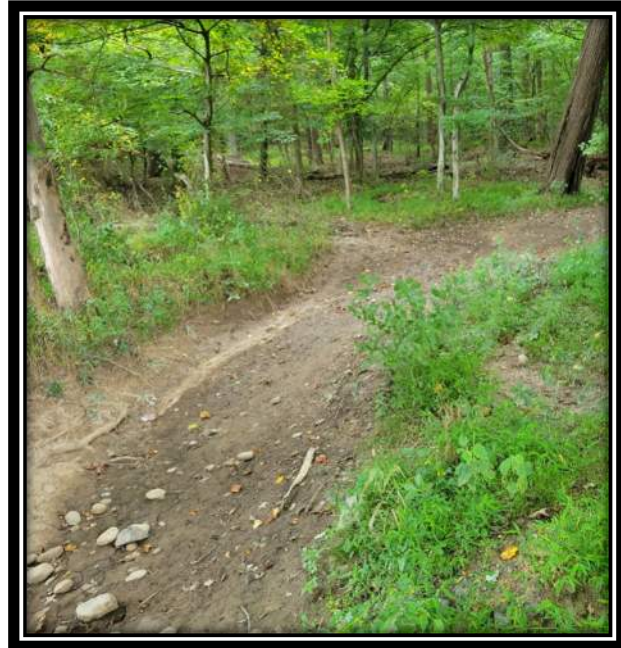
Figure 16. Area where pipe was removed and "ford" was by default created. Backwater is causing washout of the upstream portion.

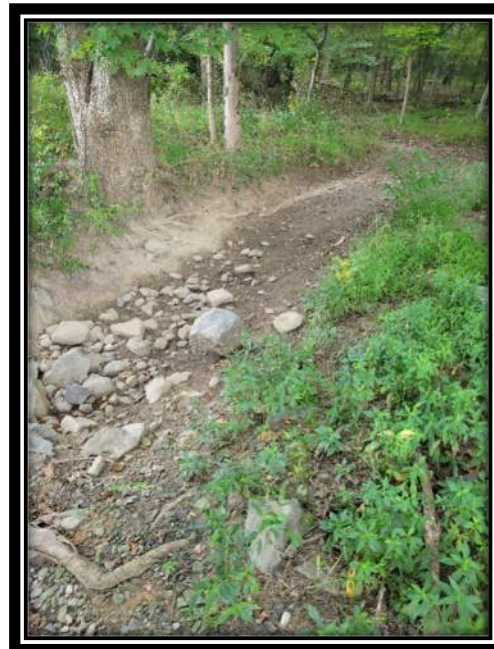
Figure 18. upstream of ford showing washout.

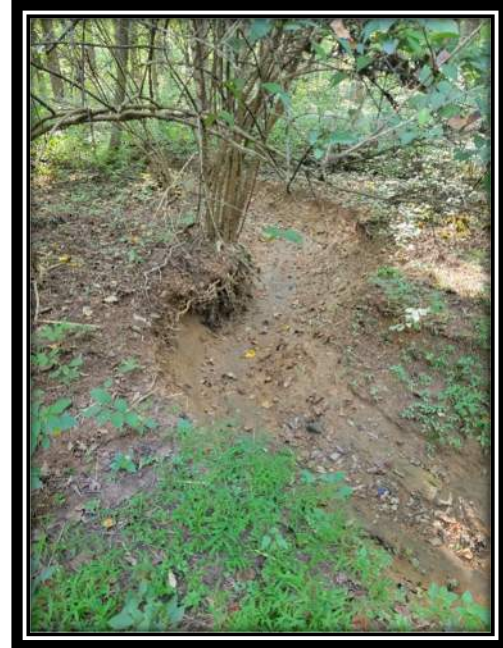
Figure 22. Channel forming from what was shallow concentrated flow. Tree that once provided protection is now compromised due to higher shear stresses.

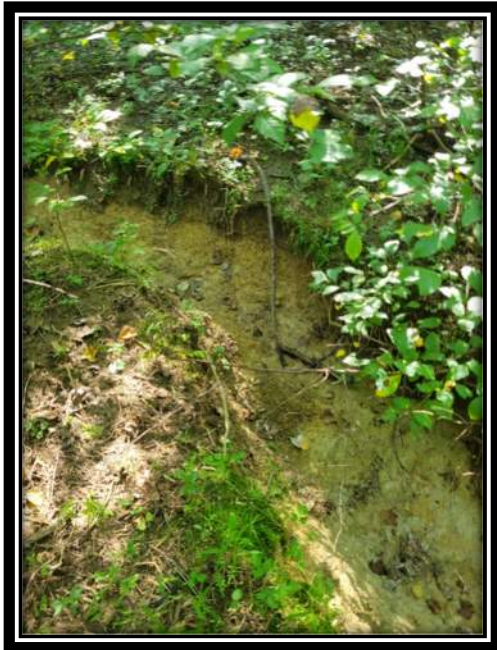
Finally a bit south of this area there is a portion of the stream that has severe lateral erosion as well as minor vertical cut. This portion of the stream appears to be where the transition from ephemeral and intermittent switch to perennial with a nice base flow. This portion of the stream as illustrated in Figures 23 and 24, is contributing major amounts of sediment from the banks as well as minor amounts from channel bottom.

Figure 21. Perennial stream showing scour at the outer bends which are signs of lateral migration a departure from stable conditions.

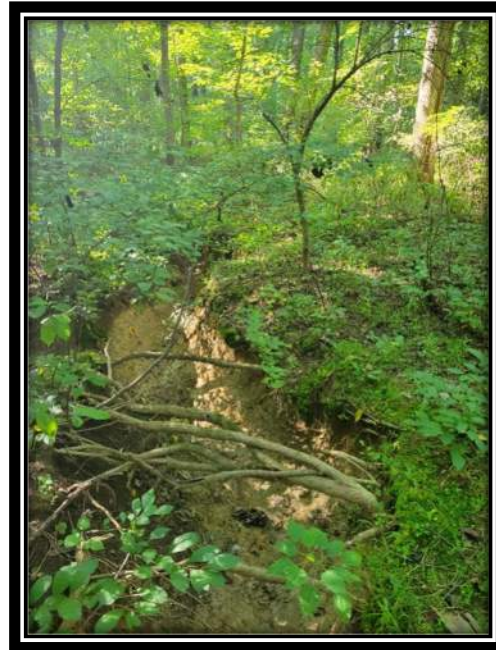
Figure 22. Tree roots show where soil used to be when this was a sheet/ shallow concentrated flow condition and now it is a incised entrenched channel.

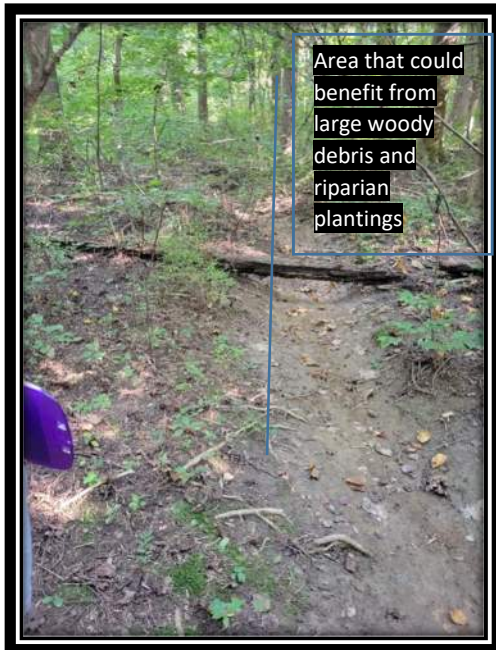
Figure 23. Ephemeral stream that could benefit from plantings

In the short-term the community needs to find a way to reduce the impacts of the runoff that are contributing to their sediment load and degradation of their infrastructure. To address this a distinction needs to be made between upstream of the reach and downstream in the reach. One observation that was a pattern throughout the watershed was that the upstream portions of each reach, where they meet the storm drain, or are within 200 feet of the storm drain, did not appear to be in severe states of departure from stable conditions. In these areas, plantings of low light riparian plants would help to establish surface protection from flow as well as increase the chances for shallow concentrated and sheet flow.

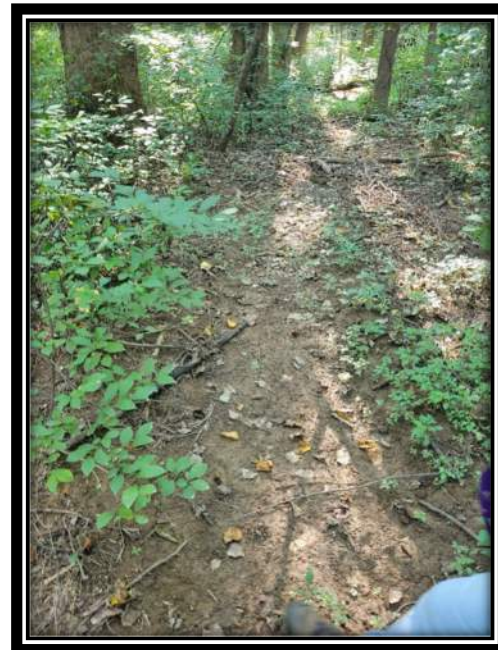
Figure 24. Area of sheet flow that is showing signs that it will start eroding.
