Town of Washington Grove
Stormwater Management Assessment
Date August 23, 2023

**Prepared For: Town of Washington Grove
300 Grove Ave Washington Grove MD**

WASHINGTON GROVE EAST STREAM ASSESSMENT AND RECOMMENDATIONS

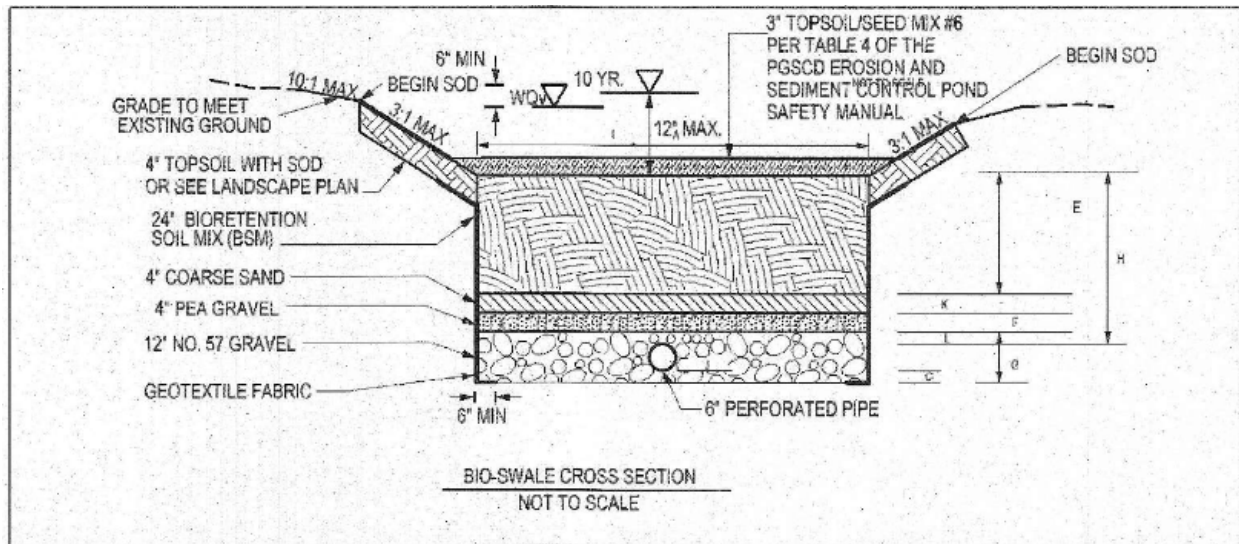
As seen in Figure 4. below the typical bioswale will have a flat bottom width with side slopes of 3:1 at a depth between 1 and 2 feet. Below the surface at the bottom is a layer of gravel sand and biomaterial.

Figure 4. Bioswale typical section. As can be seen there is a bottom width that is flat then side slopes at 3:1. Below the surface is multiple layers of soil mix, sand and gravel.

Having bioswales at the locations of the asphalt swales would encourage infiltration and reduce the amount of runoff that is delivered to West Woods. A soils investigation is needed to determine the effectiveness of these devices however any amount of infiltration will enhance the capabilities of the system. The increase in infiltration will reduce stormwater runoff and reduce erosive flows in the west woods stream. The larger swale section will convey a larger volume of water and route it through a system that will control the flow so that it does not erode out the stream in west woods. The increased size in bioswales can be accomplished through grading within public right of way, minor roadway width reduction and grading easements from adjacent property owners.

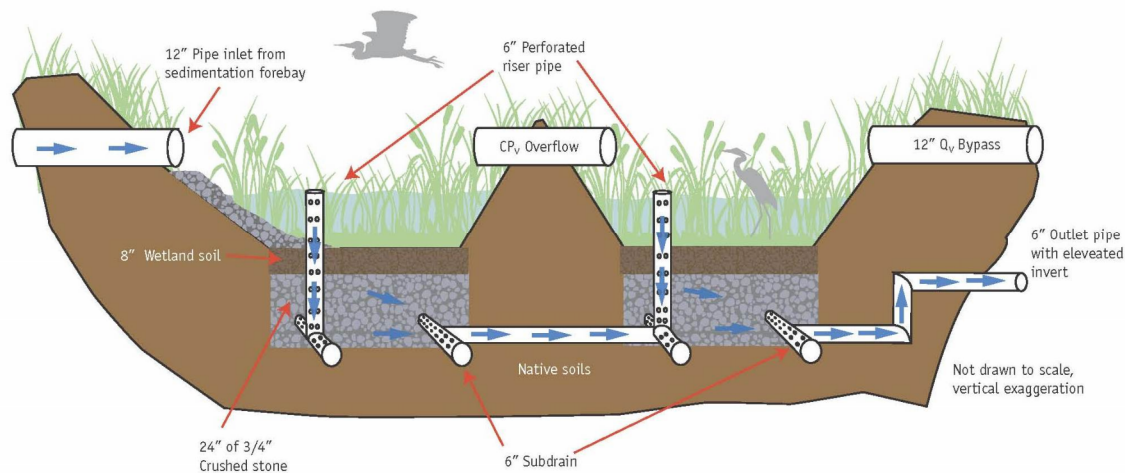
Figure 5. Submerged Gravel Wetland cross section. As seen the water has two points of discharge. One is a low flow 6" outlet pipe that lets water out slowly after it has had time to infiltrate through the wetland stone. Second is a bypass which is shown here as a pipe but could also be a weir outfall.

A potential stormwater management strategy would be to place a submerged gravel wetland to be placed at the location at Center street on site that facilitates ease of drainage of water that would otherwise contaminate the west woods with water that is nutrient laden. As seen in Figure 5. Below the submerged gravel wetlands' plug flow reactor design allows for water to be treated and also allows a reduction in peak discharge without infiltration into the native soil material. An underdrain will tap into the existing storm drain system that will receive the subsurface effluent that is treated water that will be delivered to the stream across from. Washington Grove Lane. The installation of this device would provide water quality treatment and quantity control and could assist in reducing flooding on Washington grove lane. Since the water will be stored in the subsurface and discharged slowly through a low flow underdrain, and the device will be able to store a volume of water, the peak flow will be reduced during rain events and will decrease flooding on Washington Grove lane as well as decrease erosive discharges at the direct discharge point on Washington Grove Lane where the stream headwater channel begins.

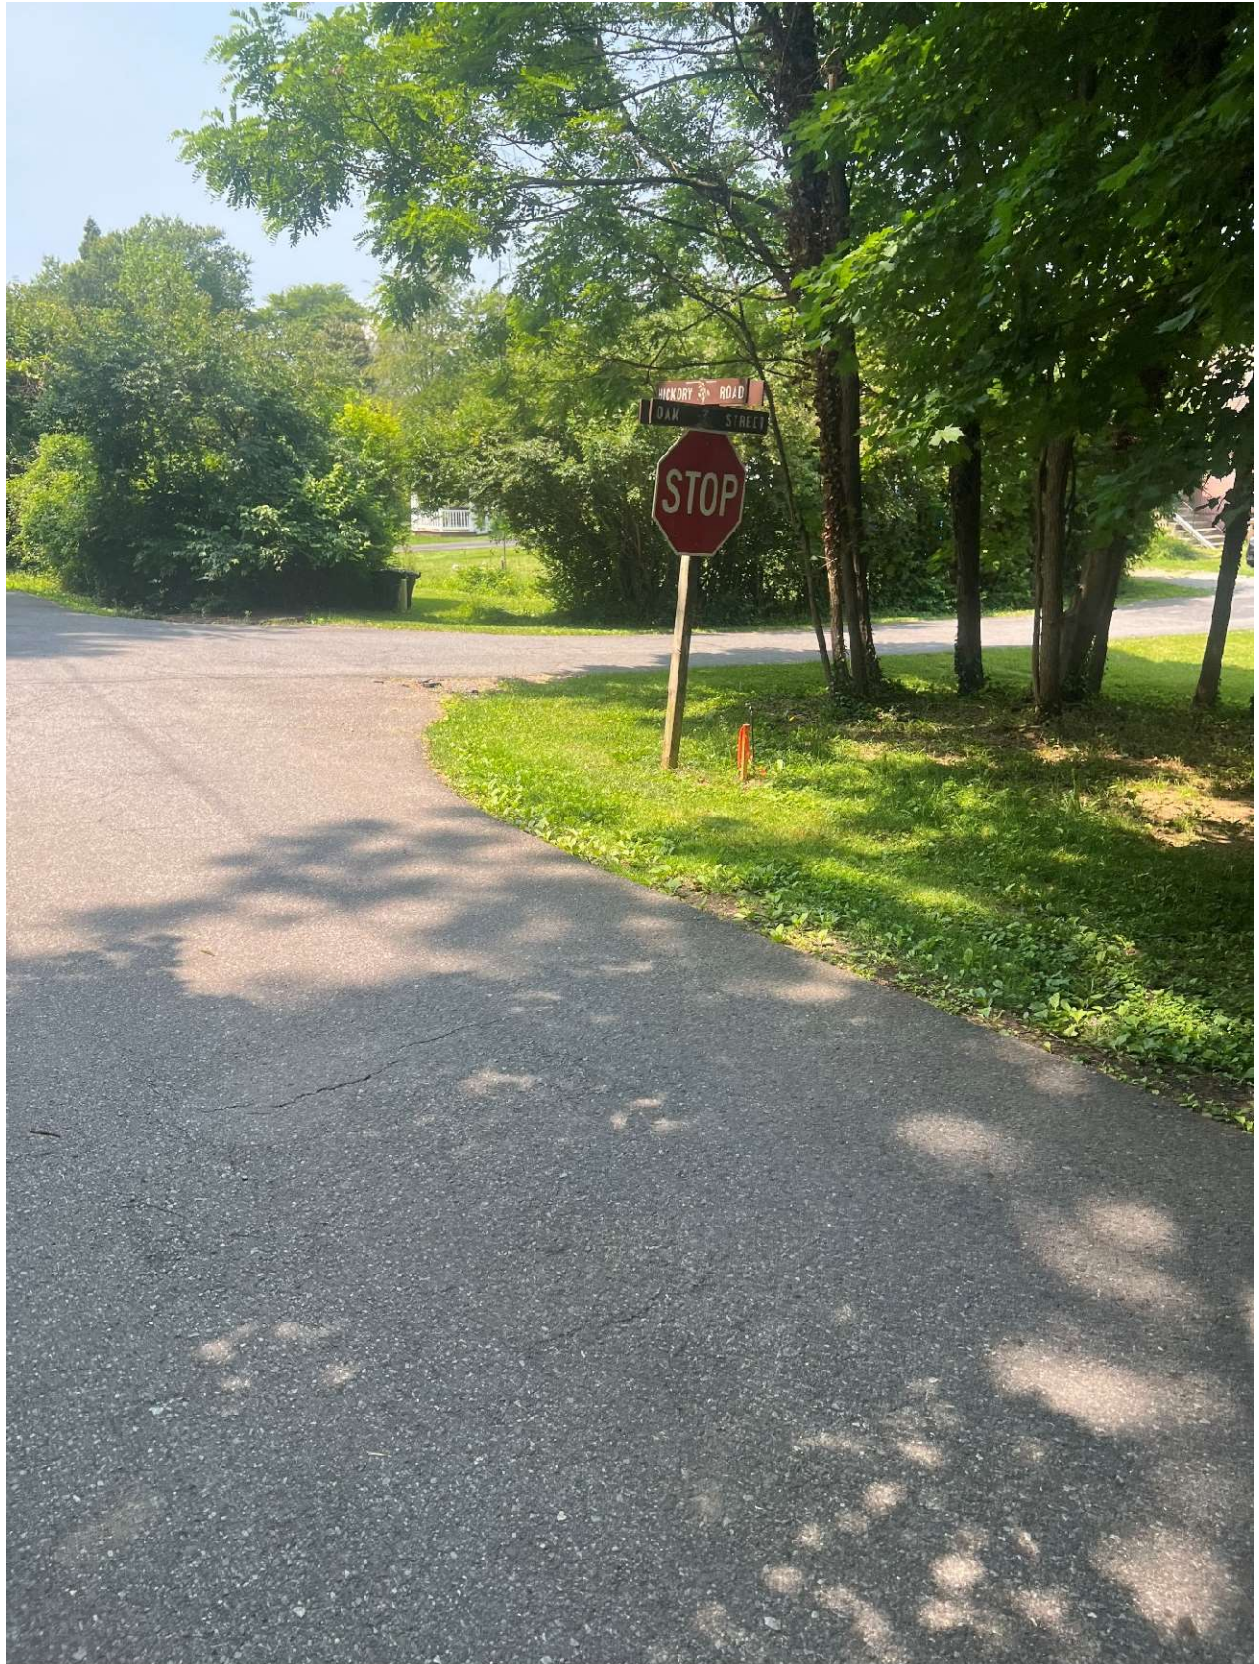
South East corner of the intersection – Good condition

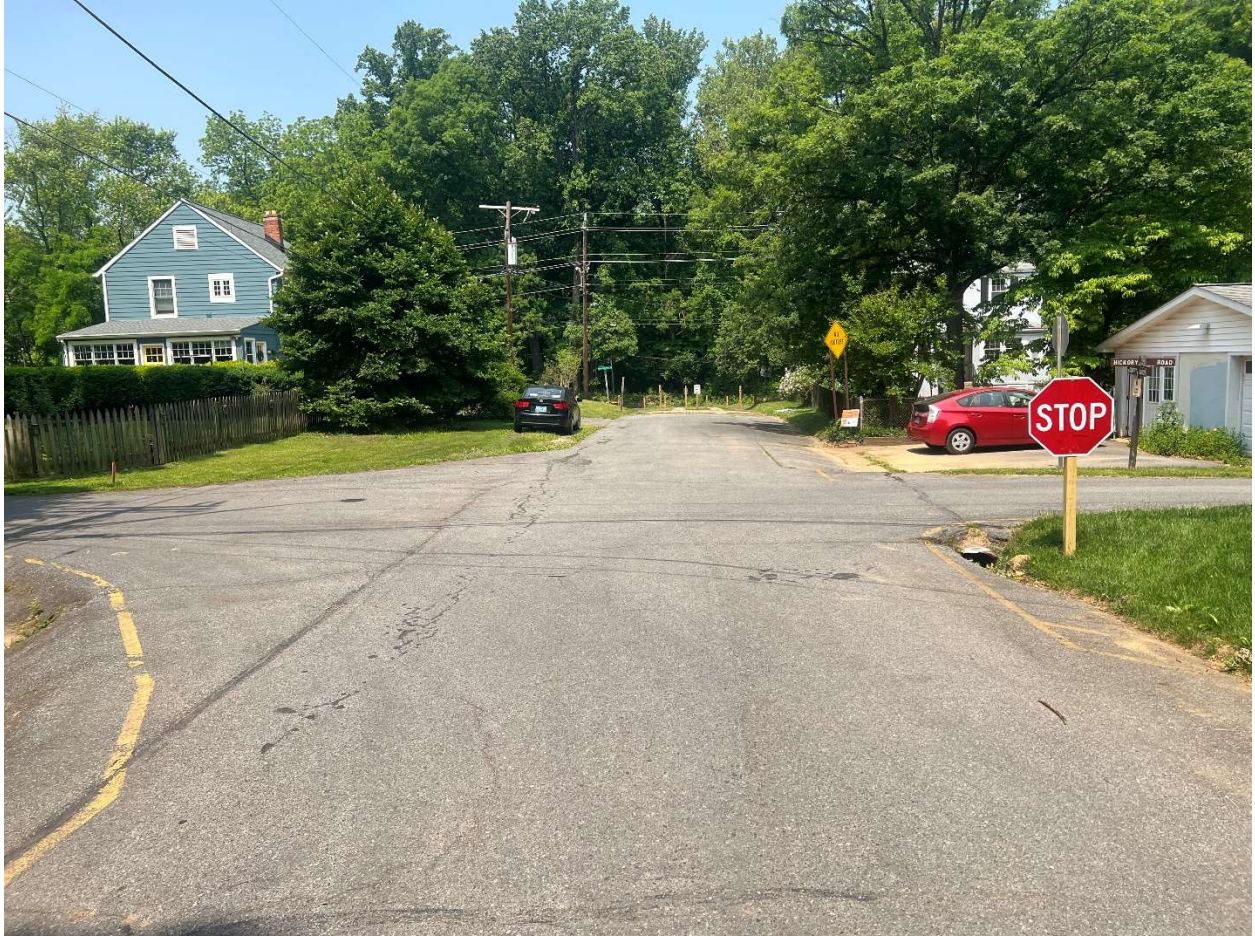
Standing on Center Street Looking towards Washington Grove Lane at intersection of Center Street and Hickory Road

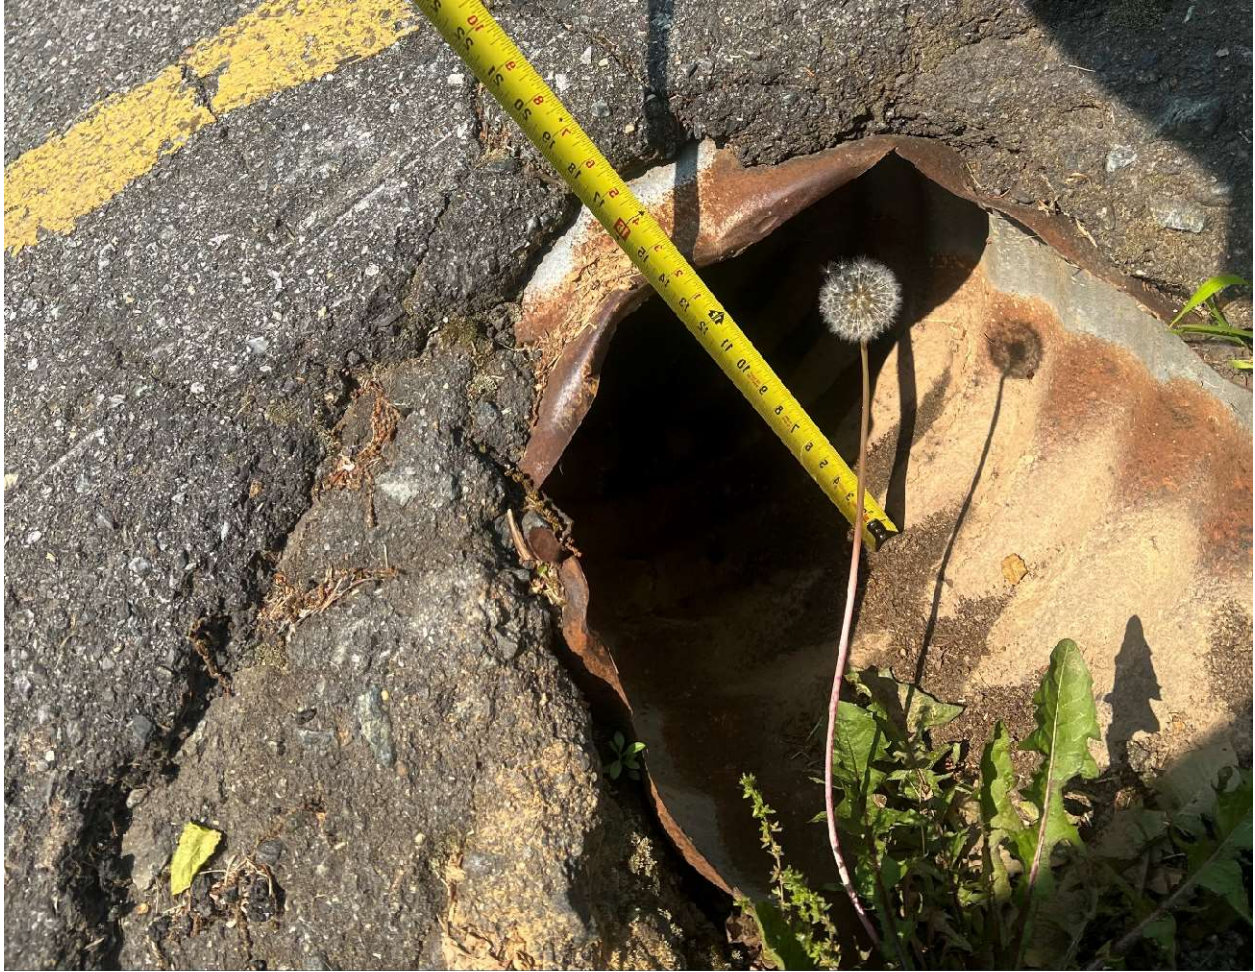
14" SD at invert in Southeast Corner of Hickory Road and Center Street Intersection

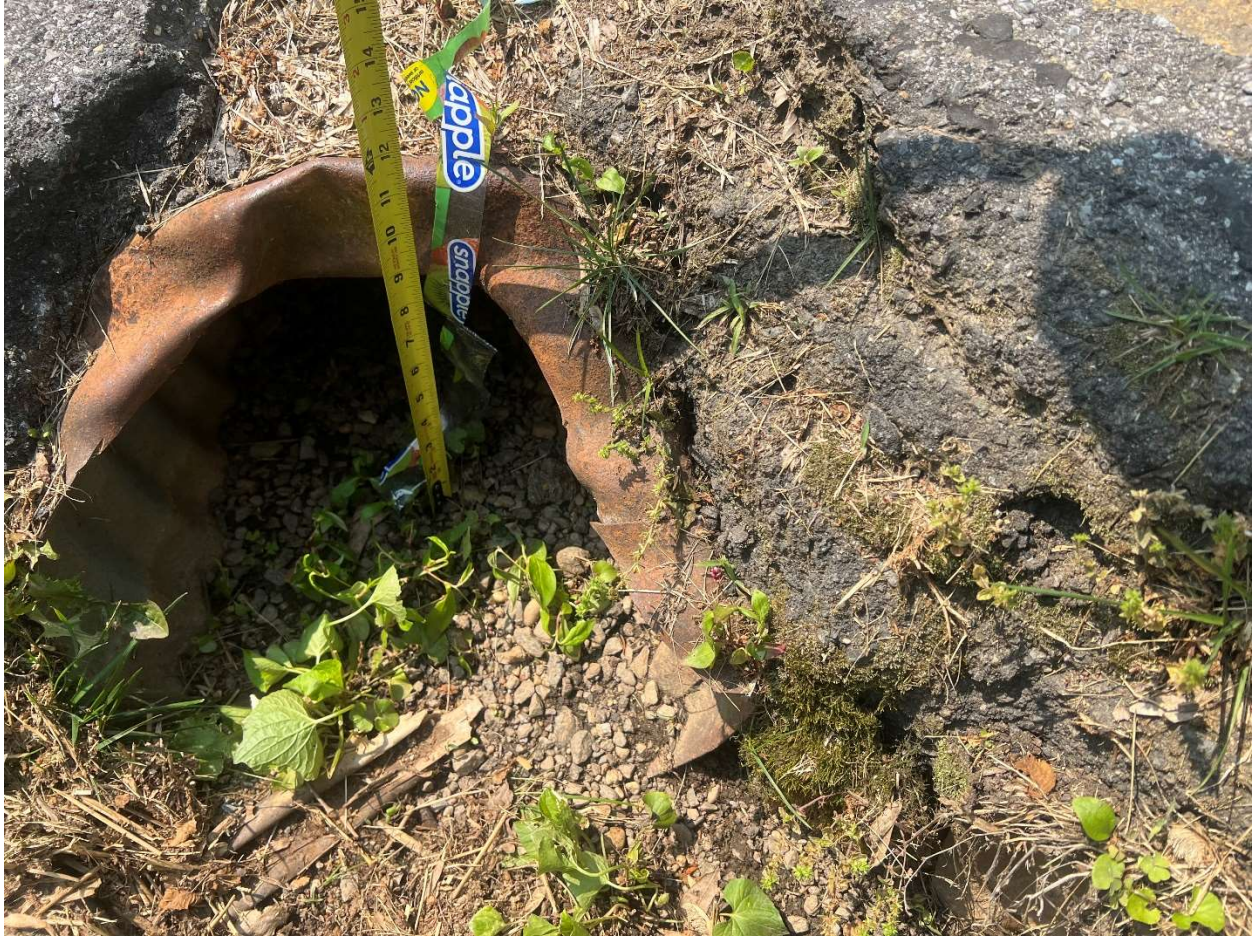
Invert Out at Northeast Corner Location of Hickory and Center Street

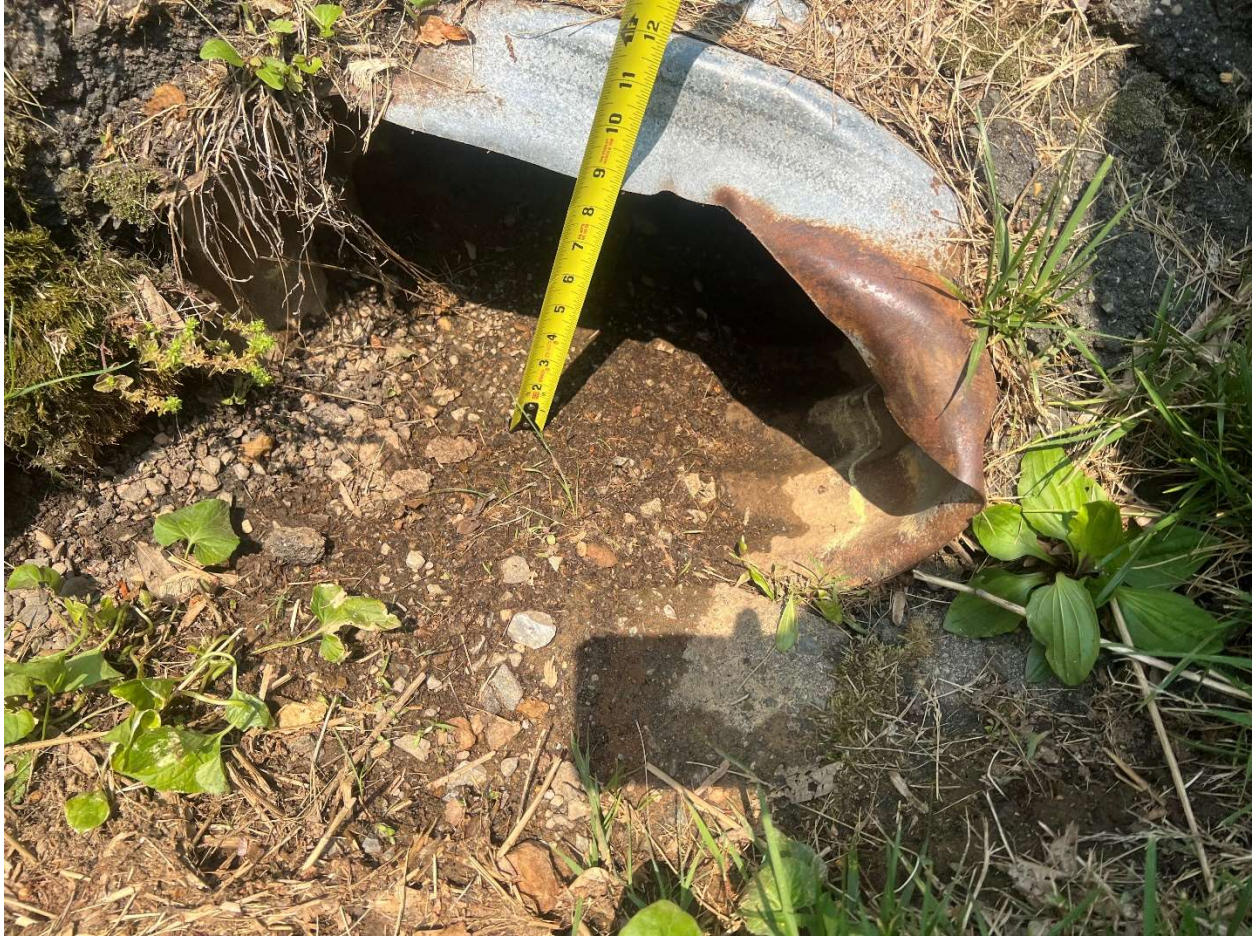
Invert In – Northeast Corner of Hickory and Center Street

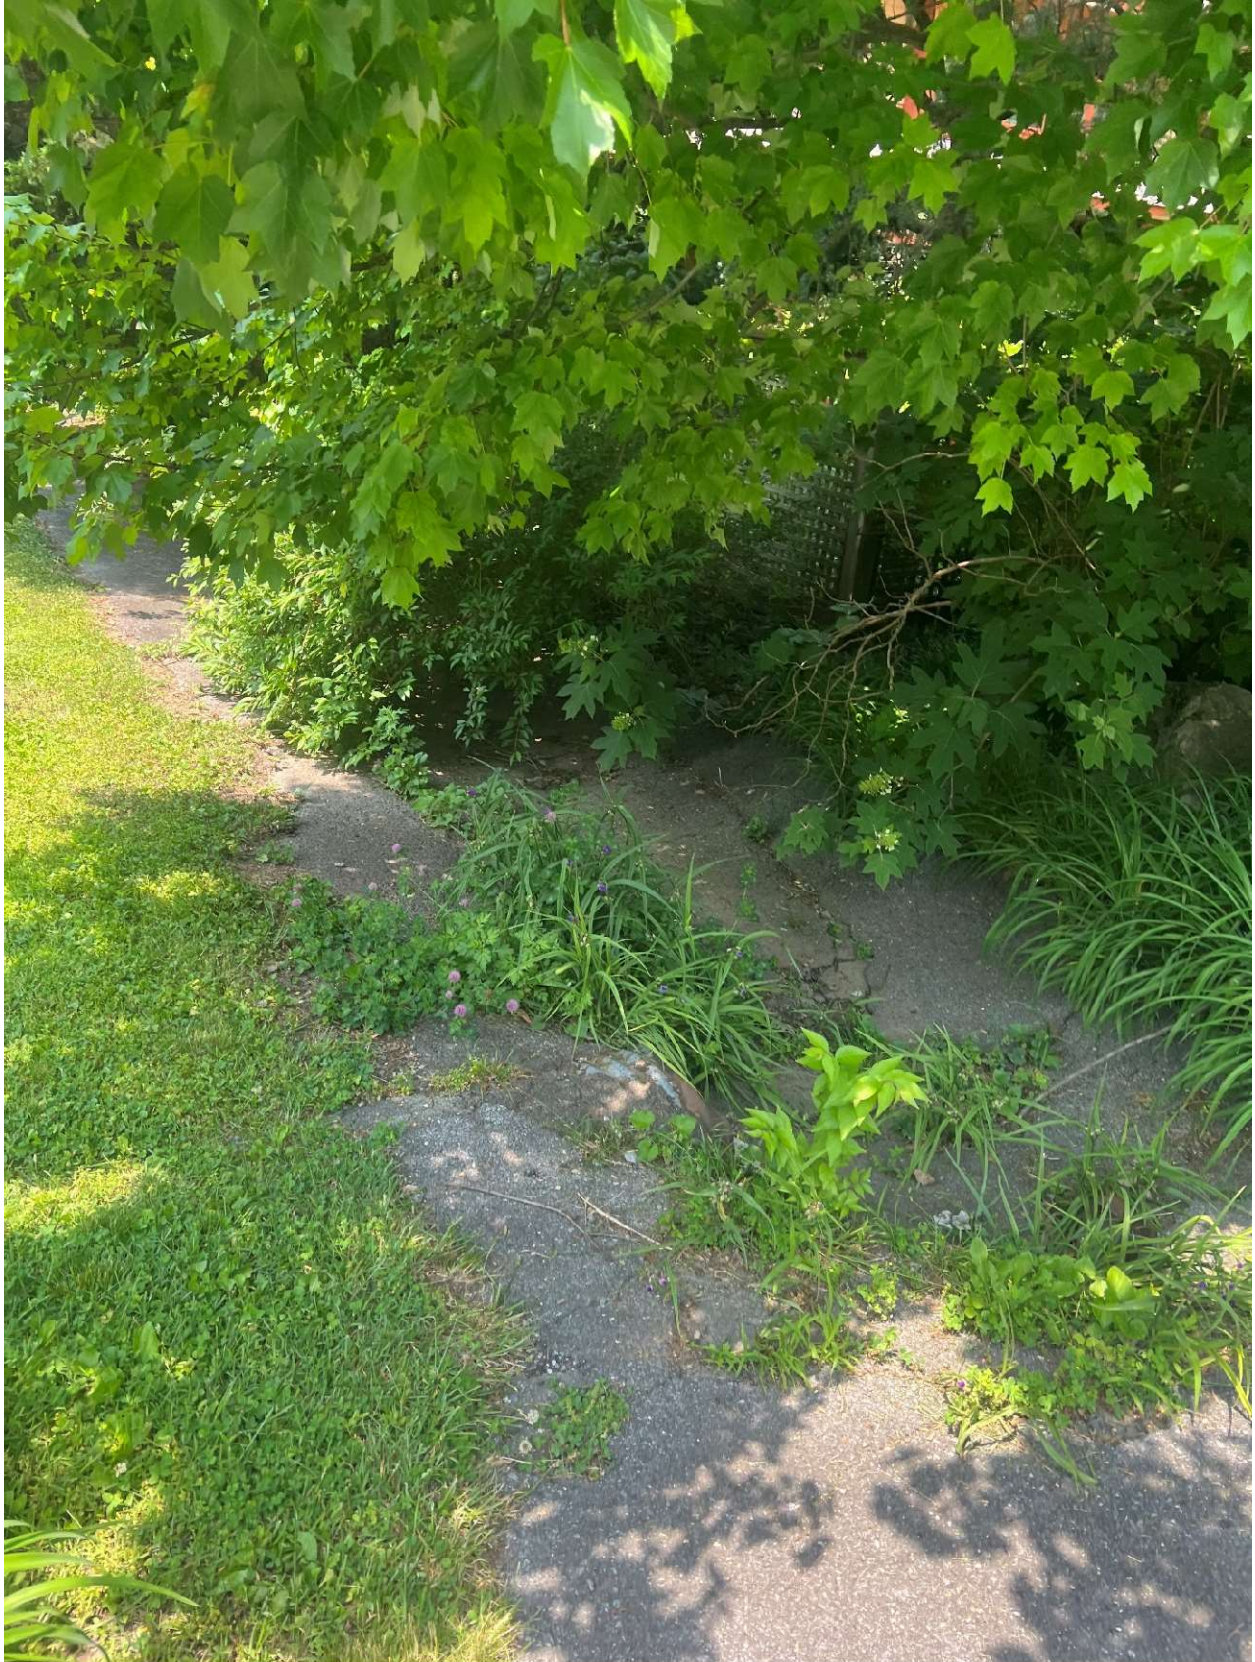
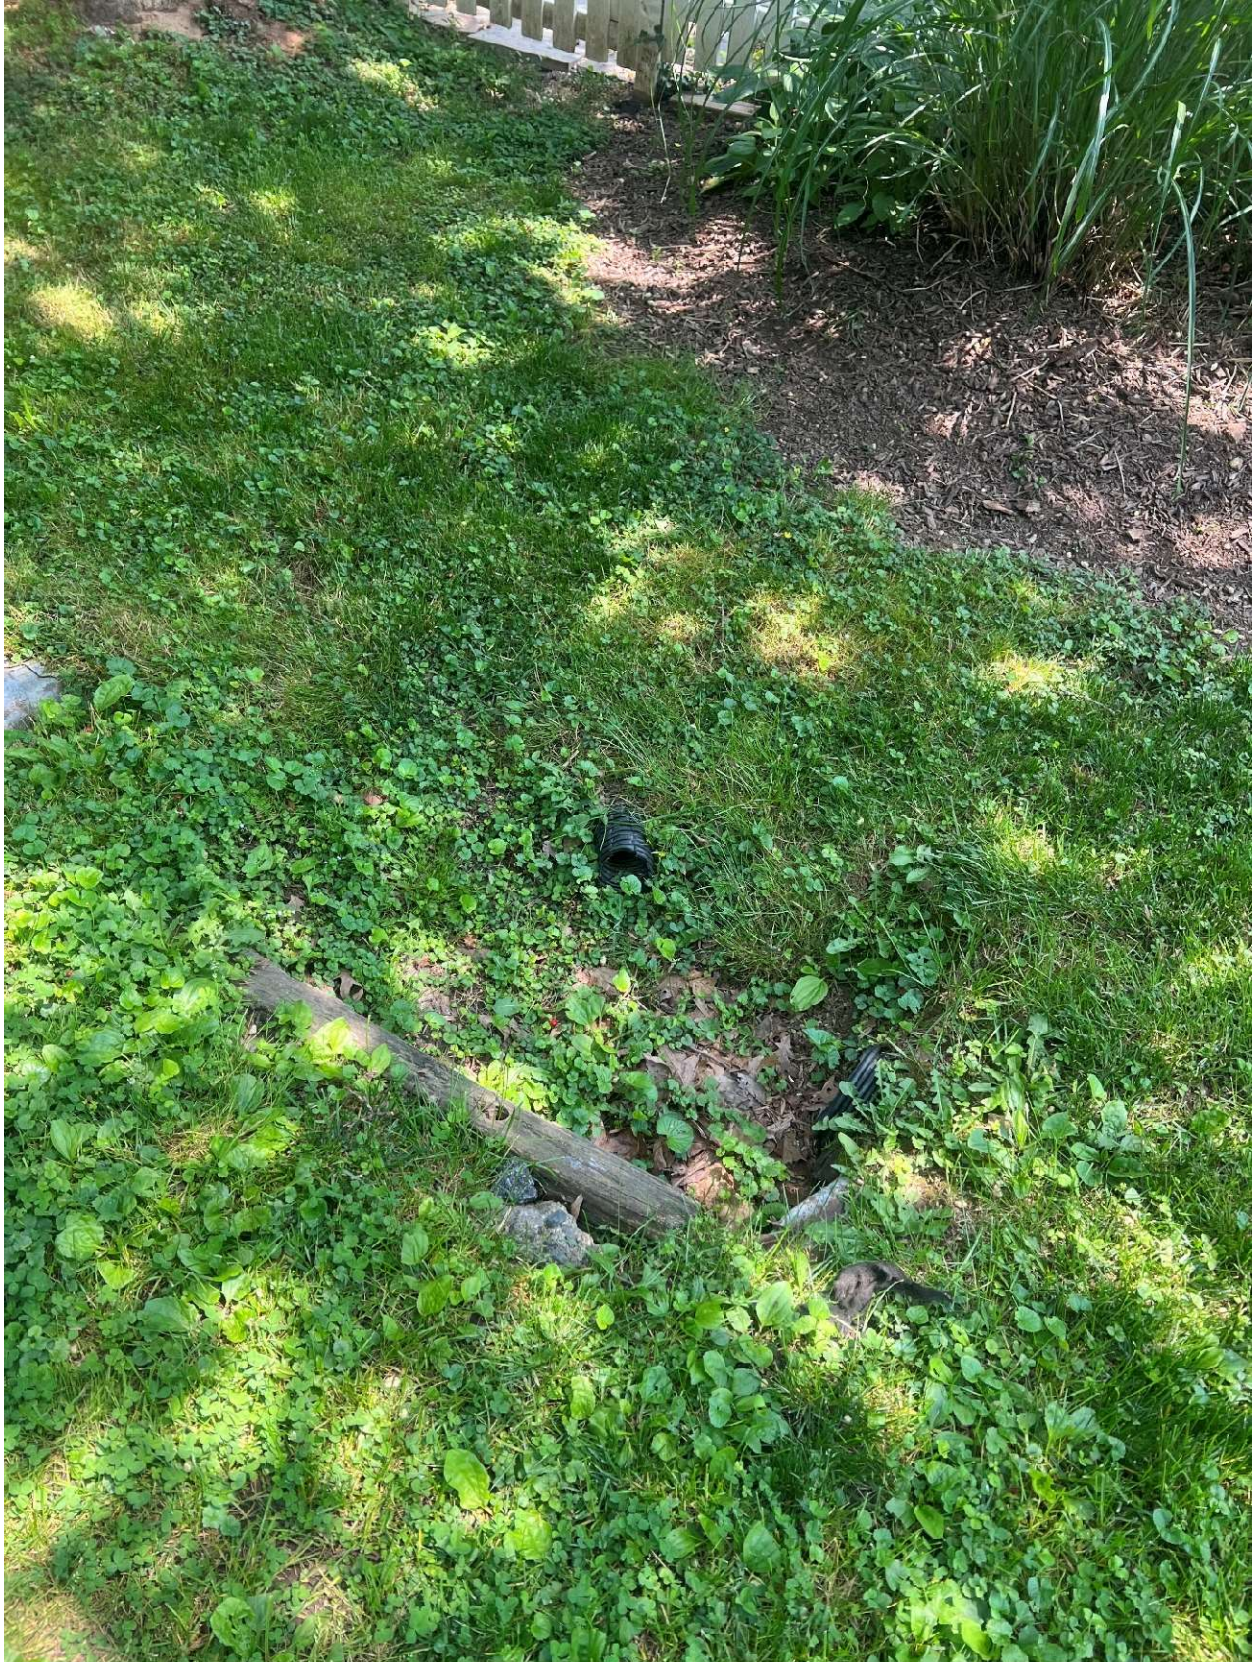
Nearby inlet pipes to asphalt channel

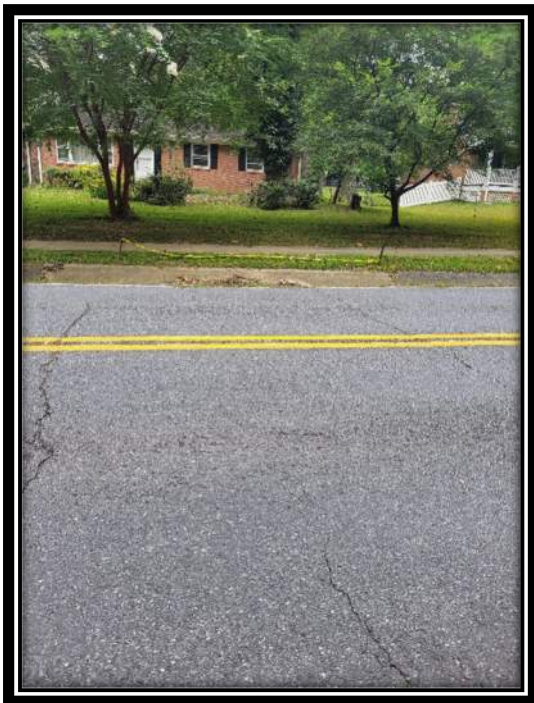
On Washington Grove Lane there is a 200' catchment that receives runoff from the town of Washington Grove. On The downstream side of the system where the outfalls are there is evidence of accelerating erosion. Pictures 1 and 2 show the catchments and the downstream erosion.

Figure 1. Catchment for Washington Grove Westwoods

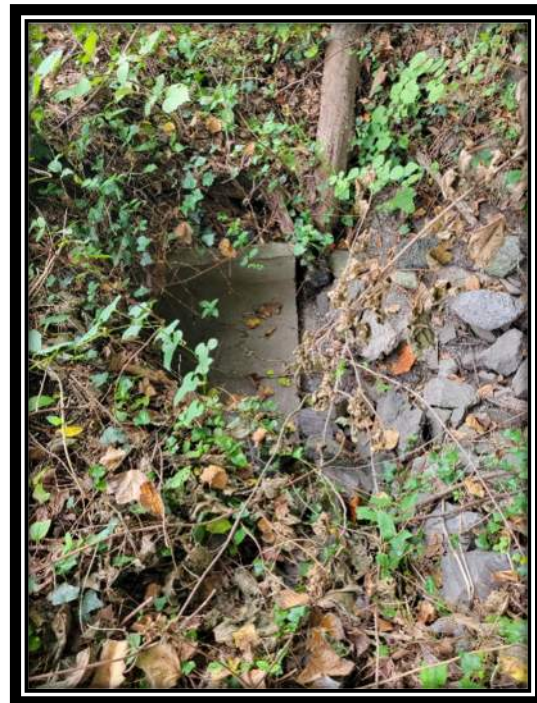
Figure 2. Catchment downstream of Washington Grove Lane

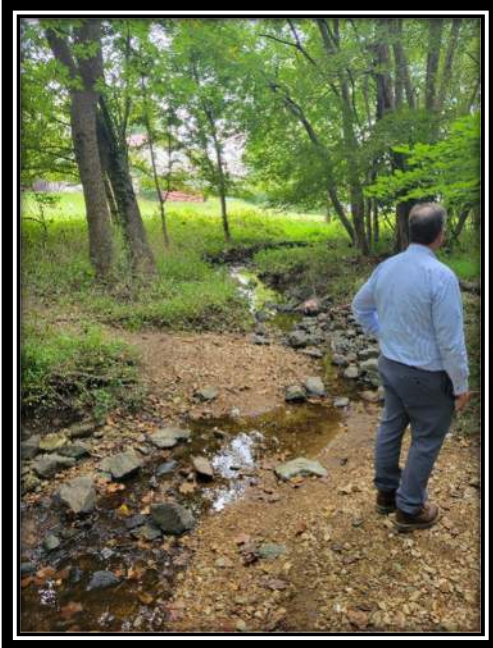
The aforementioned reach along with the downstream portion of Whetstone Run converge at the location shown in Figures 15 through 18. Once the stream reaches here it appears that a stream restoration was constructed recently beyond the confluence where it flows into Kelly Park. At the crossing between the stream and the trail, the municipal leaders informed us that there was a culvert here; however, it had been removed and filled with stone. Now the ephemeral channel backs up to the invert of the upstream portion of the “ford” and creates a backwater condition that is washing out the upstream end for some ways. Also, there is a risk of potentially blowing out the stone ford. A pipe that can safely pass the 10-year flow ought to be placed here to provide safe passage for pedestrians and reduce erosion and deposition risk of the crossing and ephemeral stream.

Figure 15. Confluence of two streams. Restored reach can be seen left of Jason.

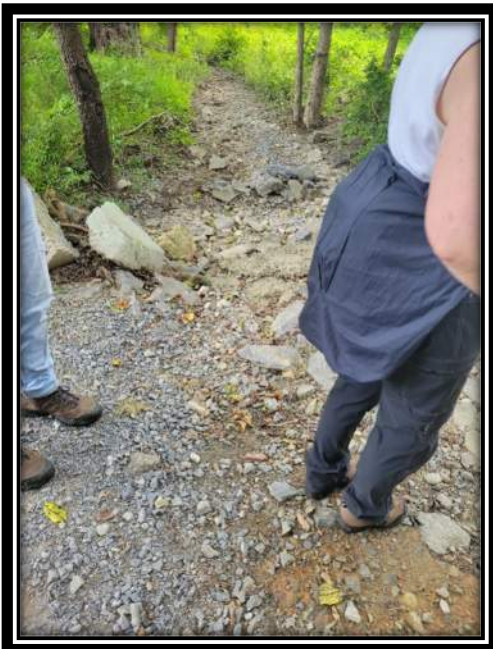
Figure 17. Stream crossing at trail and ephemeral ditch

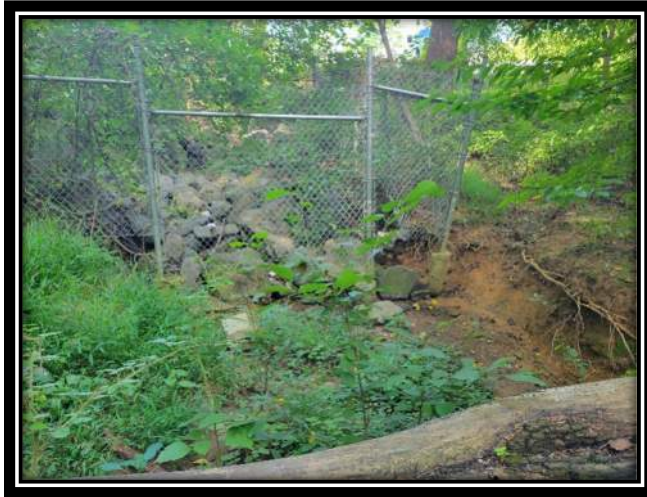
Moving upstream further north and to the west of the Town Crest Apartments, is a channel fed by the parking lot and surrounding property of the development. Figures 21 and 22 show that the pond is blowing out and there is incipient erosion of the channel. Similarly, to the south-end where the Catchment in the road had an outfall that was beginning to show signs of changing flow regime from shallow concentrated to channel flow, this intermittent ditch is as well showing signs of change.

Figure 21. Outfall pond downstream of Towncrest Apartments

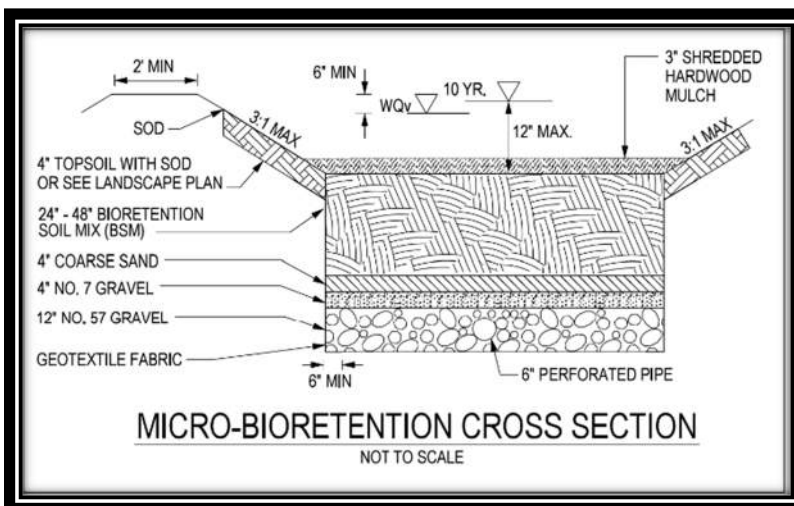
Figure 25. Microbioretention device.

The long term solution combines multiple strategies that would be helpful for meeting MS4 goals for the County as well as protecting the natural resources present on site. In the contributing drainage area of the streams on the west side of Washington Grove Environmental Site Design (ESD) could be utilized to encourage infiltration into the groundwater prior to reaching the stream channels. Figure 25 shows an example of micro-bio retention, which is an ESD practice.

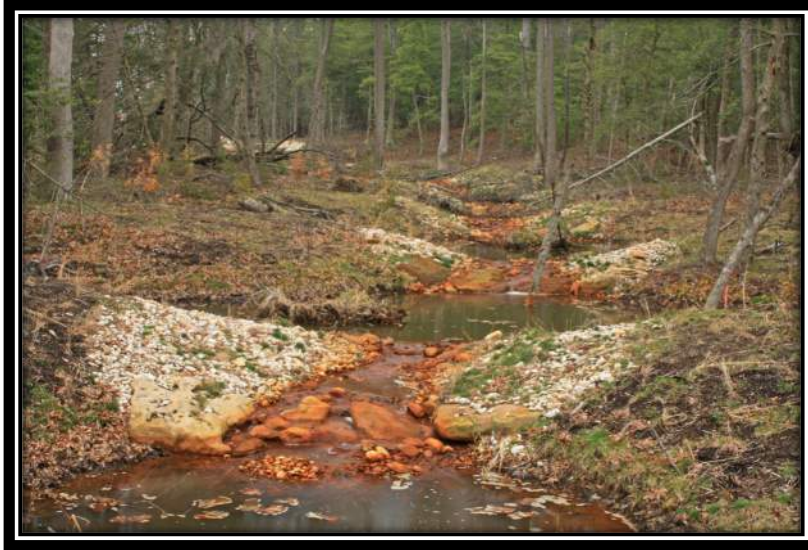
Figure 26. Regenerative Step Pool Storm Conveyance Example.

For the streams that are fed by Maple Spring that had evidence of down cutting, an outfall protection could be used that would create step pools that would connect the water table to the floodplain, bringing back wildlife to the stream. Encourage increasing hydraulic residence time in the stream and

slow the water down to release it at a rate that is non-erosion and brings back the stable condition. The subsoil would have the capability to increase filtration through the use of a sand-and-wood chip mixture that will clean the water as it passes through. Figure 26 shows a regenerative step pool that would be used for the outfall protection.

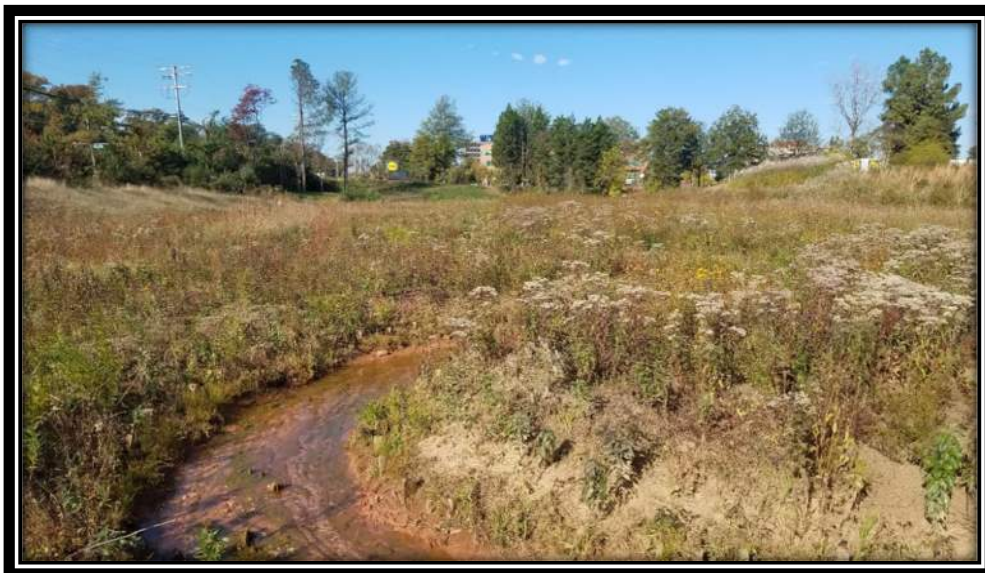
Figure 27. Soltesz designed natural channel design in Lanham MD still stable after 2 years post construction.

For the streams fed by the storm drain from Towncrest and the surrounding area, a natural channel design approach would be appropriate to encourage floodplain connectivity, wildlife habitat, and raise the water table. This would be accomplished by raising the stream channel to match the stable channel dimension pattern and profile then add structures such as cross vanes, J hooks, and toe wood or soil lifts to stabilize the sections. Figure 27 shows an example of natural channel design.
