AUTHORIZING THE SALE OF LAND OCCUPIED BY A MAIN BUILDING
AT 315 GROVE AVENUE INITIALLY CONSTRUCTED IN PART ON
LAND OWNED BY THE TOWN OF WASHINGTON GROVE

EXHIBIT B Ordinance 2018-11

EXHIBIT C Ordinance 2018-11

315 Grove Avenue Documentation and Analysis of Historic Integrity Features

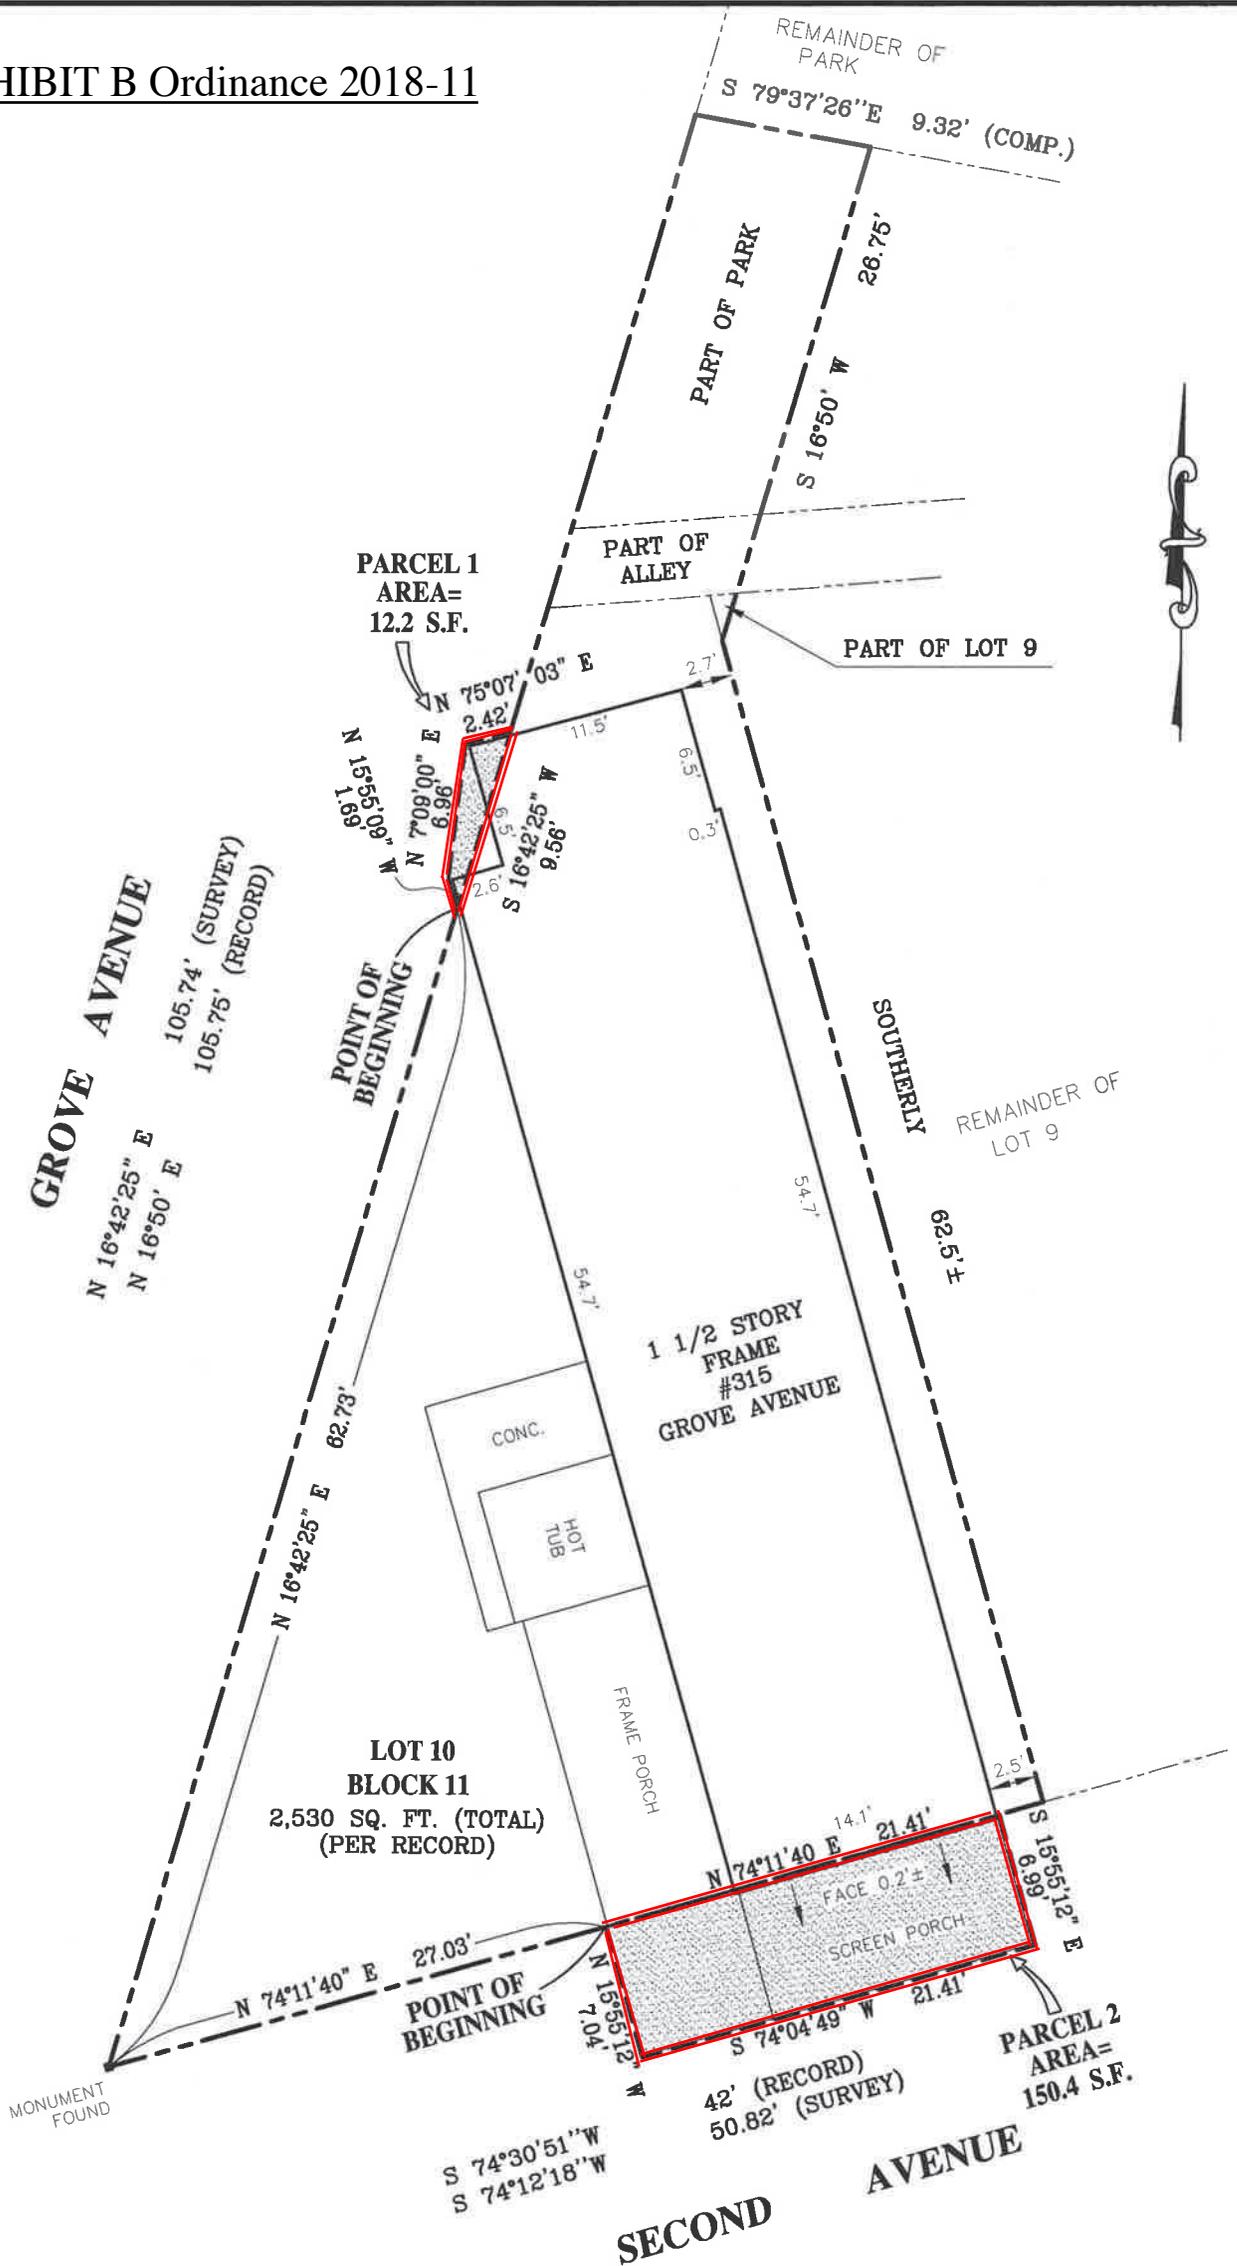
SKETCH DRAWING
LOT 10 & PART OF
LOT 9, ALLEY & PARK
BLOCK 11
WASHINGTON GROVE
 MONTGOMERY COUNTY, MARYLAND

- A. The Council hereby finds and declares that the following Town-owned land is no longer needed for a public purpose: Two parcels, Parcels 1 and 2, as described in a metes and bounds description attached hereto and incorporated herein by reference as Exhibit A, and in an Identification Plat attached hereto and incorporated herein by reference as Exhibit B, referenced as Parcels 1 and 2, (collectively, the “Town-owned land”).

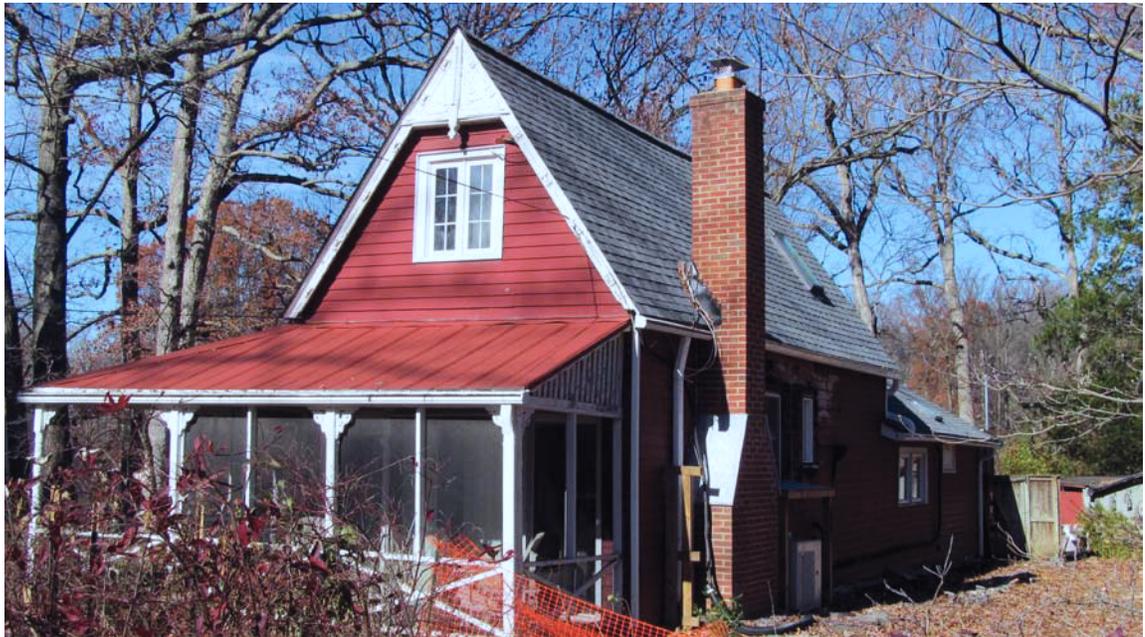
**Figure 1 (315 Grove Avenue)
Overview Second Avenue Elevation
Showing Typical Massing and Scale of “Tent District” Cottages**

It shares with other residences in the “tent district” its **small vernacular Carpenter Gothic cottage scale, massing and aesthetic**. Cottages around the Sacred Circle share many of the characteristics of its porch and telescoping additions.

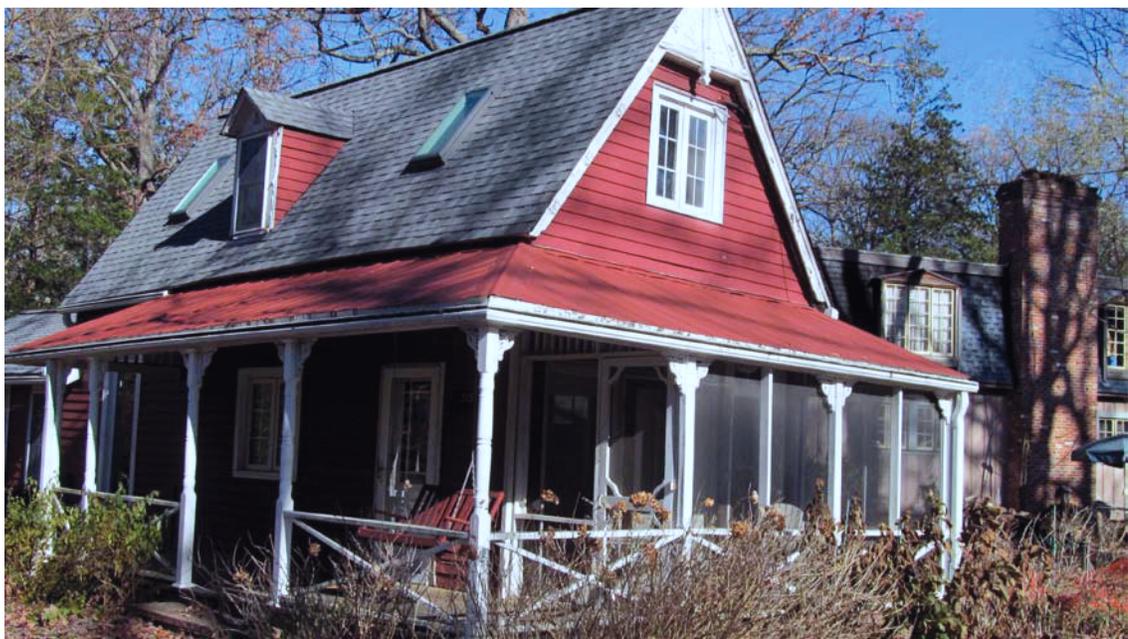
**Figure 2 (315 Grove Avenue)
Overview Grove Avenue and Second Avenue Elevations
Showing Iconic Washington Grove Carpenter Gothic Porch and Façade**

As emphasized in the nomination for the Washington Grove National Register Historic District (submitted to the National Park Service by the Planning Commission on behalf of the Town in 1979), porches are essential to Washington Grove's architectural heritage—providing an open place for social interaction, connecting the sometimes small house interiors with nature, and providing an opportunity for expressing architectural individuality. The National Register nomination also calls out “gingerbread” as a character-defining feature of Washington Grove's historic architectural integrity.

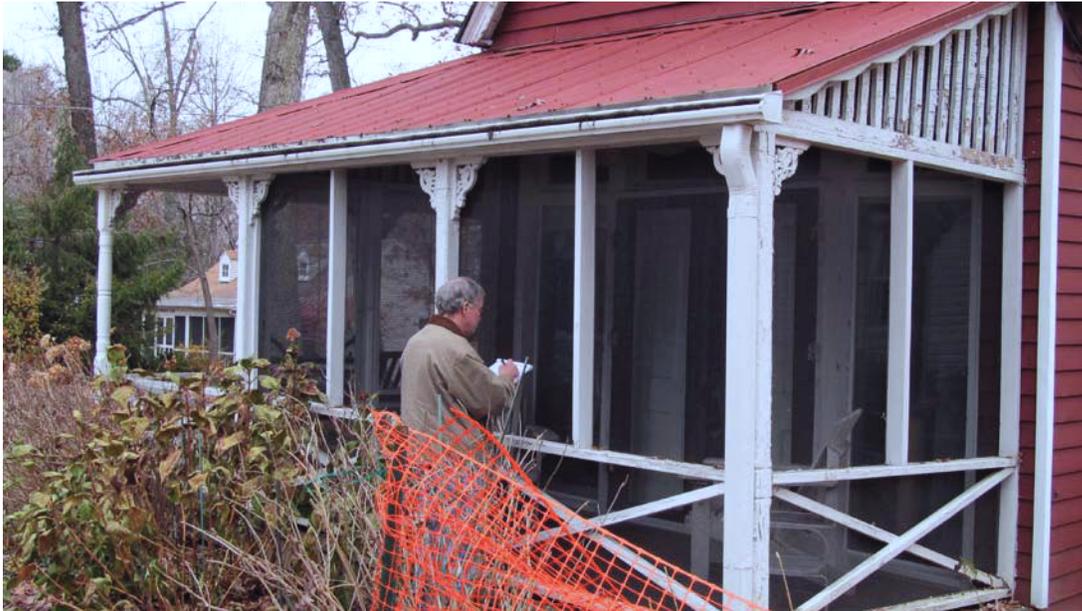
**Figure 3 (315 Grove Avenue)
East Elevation of Second Avenue Porch
Showing Square Posts, Vertical Board Lattice
Zigzag Rake Board & Sawn Board Brackets**

At either end of the screened section, a **decorative period lattice triangle of vertical 1”x 1”** is inserted at the sloped porch ceiling and serves as a squared frame for the screen. A **sloping zigzag rake board** decorates the screened section at the roof drip edge. At the Grove Avenue end of the screened section, there is also a wood screen door. The 14' wide **Second Avenue façade of the house** forms the back wall of the Second Avenue porch. This façade retains much of its historic integrity. The **original door and window casing and transom windows** remain from what probably was a composition of central double doors with side windows, since replaced. Above the **frieze board** is an **original band of turned egg-and-dart moulding, which terminates in applied acanthus leaves**.

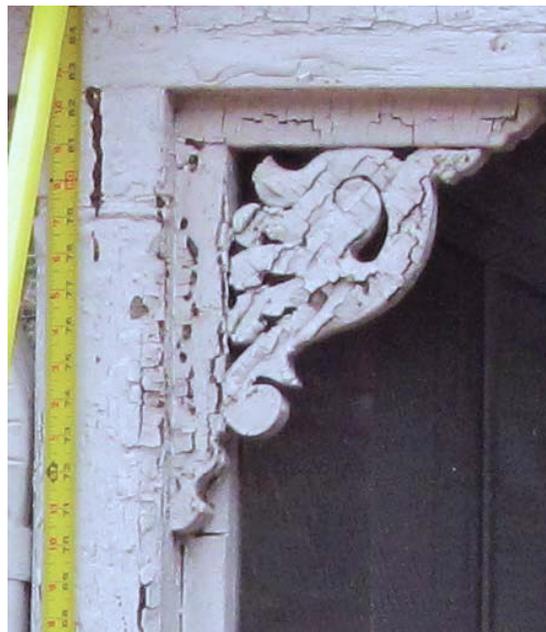
**Figure 3a (315 Grove Avenue)
Second Avenue Porch Details
Sawn Board Bracket, Square Post with Chamfered & Incised Details**

The Second Avenue section of the porch and façade of 315 Grove Ave are integrally related and particularly significant because they contain much of the extant architectural integrity of the house exterior. The **exposed open framing of the porch ceiling** reveals the **bead-board roof deck and rafters**, now topped by a modern 5-V crimped metal roof. Modern aluminum gutters and downspouts have been applied to the lower roof edge. The porch roof is supported by **three period square 4”x4” posts, with chamfered and incised details and diminutive sawn wood brackets**. Modern replacement posts topped with the period brackets turn the porch corner. Modern porch railings wrap around from the Second Avenue to Grove Avenue sides of the porch, consisting of five sections of 2x4 framing large 2x4 “X’s,” attached to the house and to the posts. The posts rest on modern square exposed wood plinths. The porch has modern exposed pressure-treated flooring and foundation.

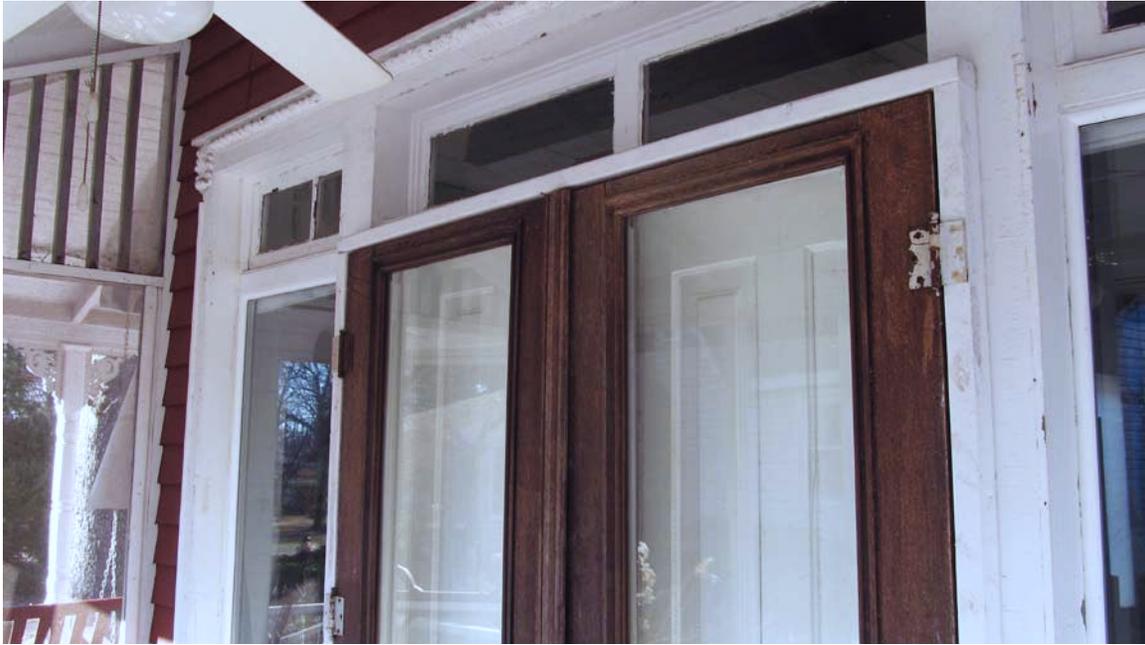
**Figure 4 (315 Grove Avenue)
Original House Façade Under Porch Roof
Original Door and Window Casings, Original Transom Windows, Lattice Triangle**

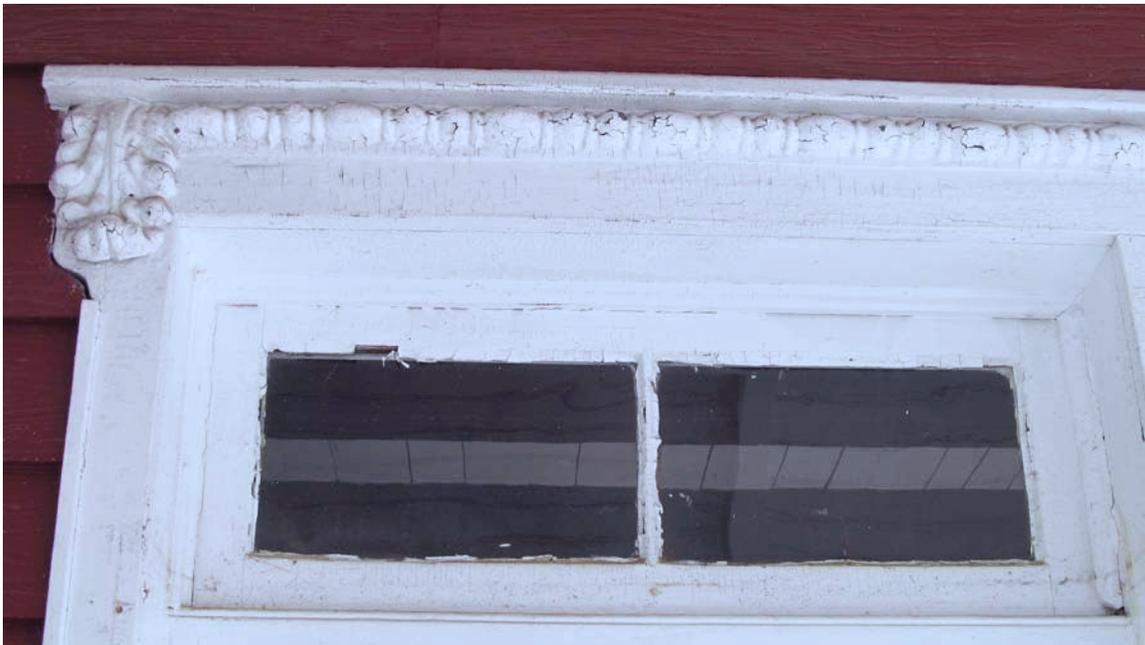
**Figure 4a (315 Grove Avenue)
Detail of Original House Façade Under Porch Roof
Original Transom Window with Applied Decoration**

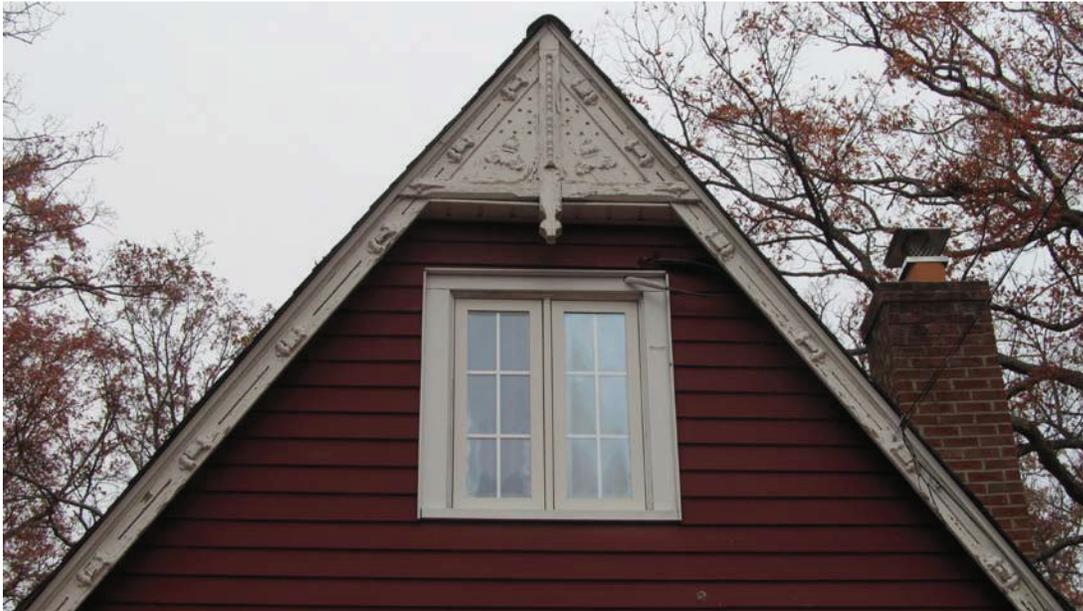
**Figure 5 (315 Grove Avenue)
Original House Façade Above Porch Roof, Deep Main Roof Overhang
Barge Board & Flat Board Pediment**

Above the **porch roof**, the original and unique faux-brick wooden house siding has been covered with aluminum siding. Continuing upward, the **steep front gable and its roof overhang** preserve an intact **decorative barge board with applied acanthus leaves and blocks, its flat board pediment with more applied and drilled decoration, and a paneled soffit closing the space behind the pediment**. It is topped off by a **decorative central drop finial**. The Second Avenue façade and porch have preserved much of their “gingerbread,” which adds to the architectural integrity of the Town.

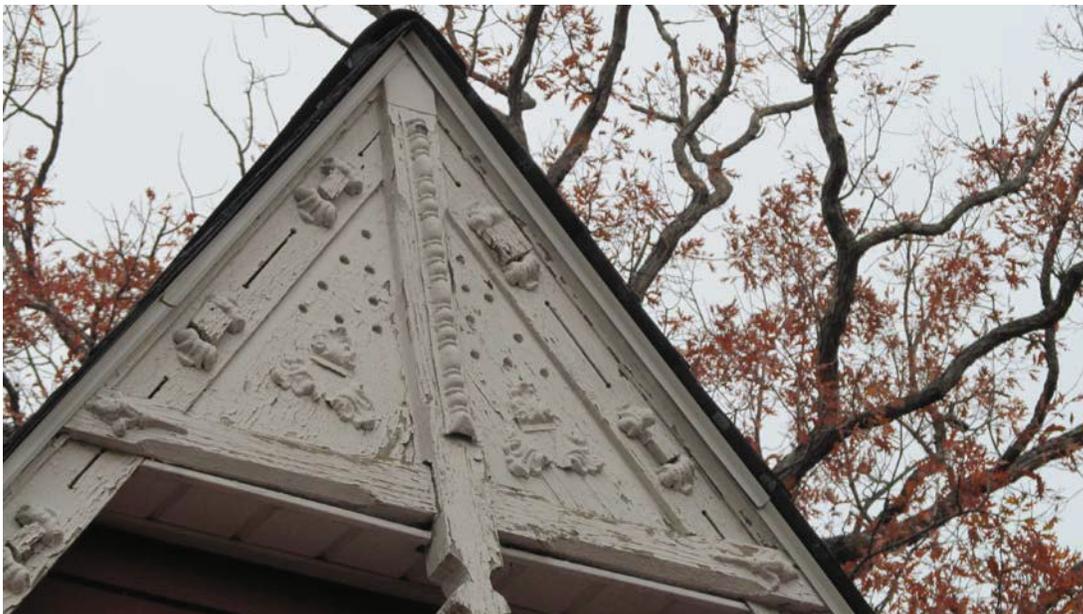
**Figure 5a (315 Grove Avenue)
Barge Board Details: Applied Acanthus Leaves & Blocks
Flat Board Pediment Details: Paneled Soffit, Drilled & Applied Decoration,
Drop Finial**

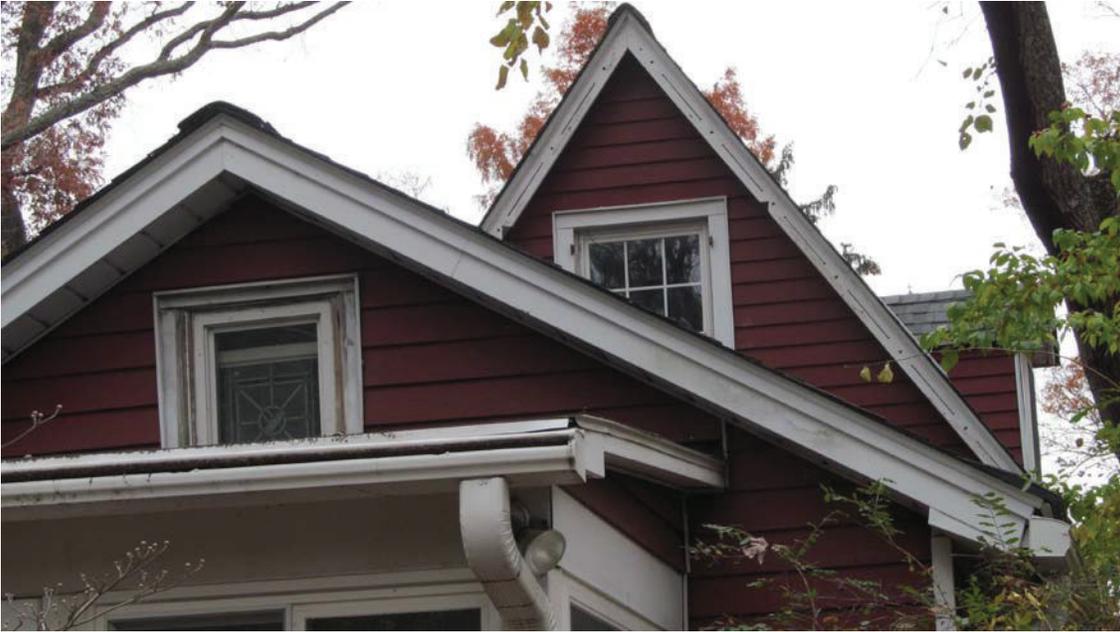
**Figure 6 (315 Grove Avenue)
Rear Elevation (Detail)
Shallow Gable Addition and Roof Overhang**

It appears from an examination of the addition and back porch that they are period structures, covered in aluminum siding and with replacement windows. **Framing members of the original back porch** are visible from the exterior. The **size, massing and proportions of the addition and back porch** are appropriate to the scale of the core block of the house and to neighboring residences. The higher roof ridge of the main block drops down to 13 feet in the addition (see County tax record in Clare Kelly house file) and drops further at the back porch. Concurrently, the styles of **the roof pitches** diminish from very steep gable in the main block, to low gable in the addition, to shed in the back porch. This exemplifies the vernacular and organic evolution and visual interest of Washington Grove houses.

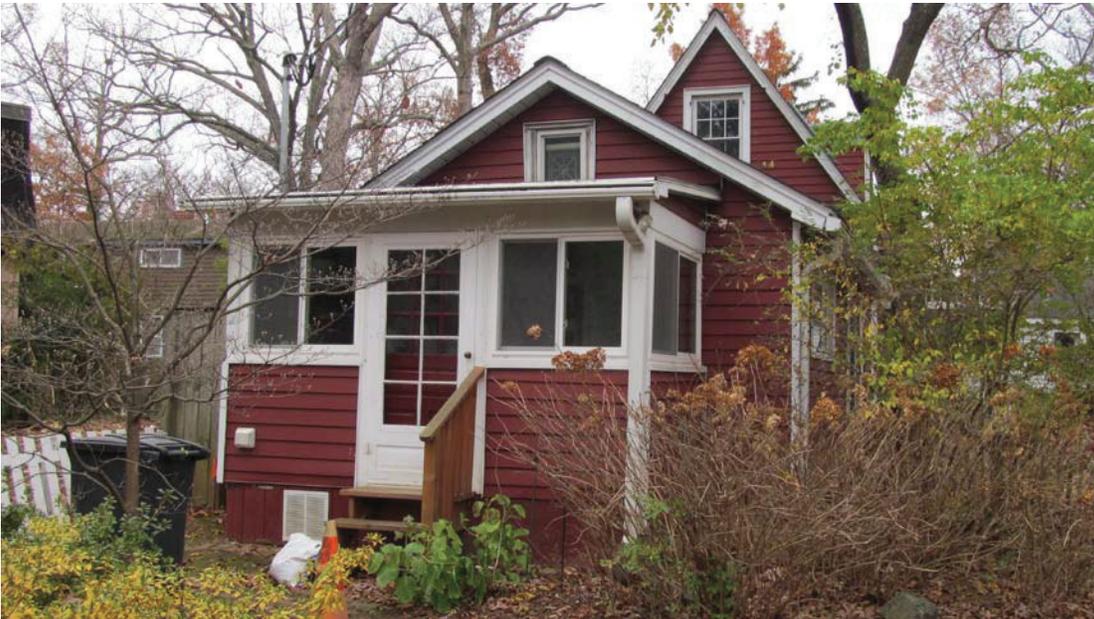
**Figure 7 (315 Grove Avenue)
Rear Elevation
Shed Back Porch Including Overhang**

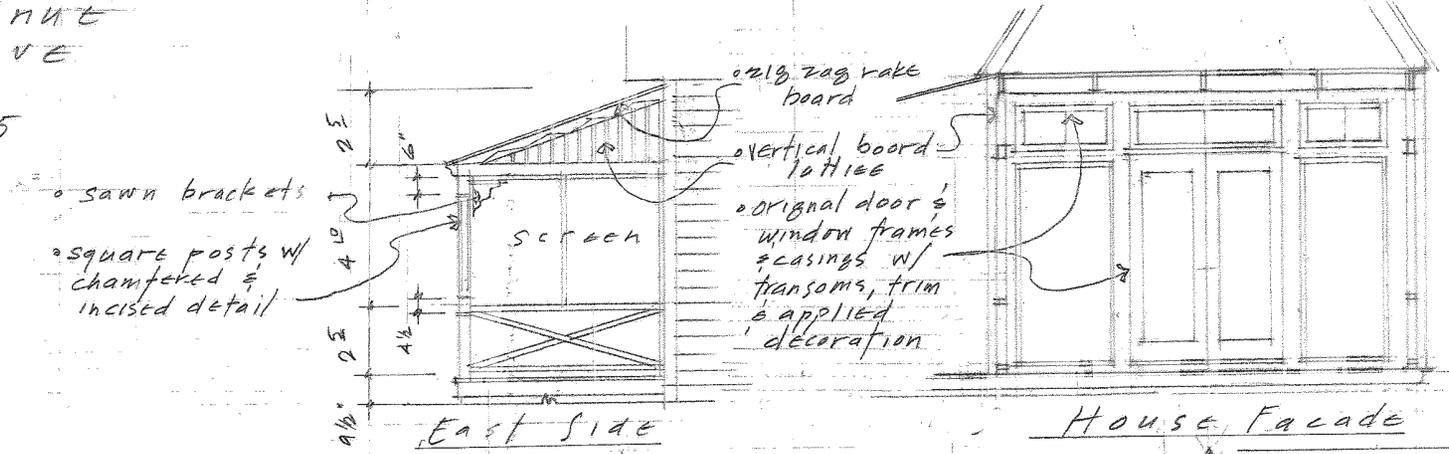
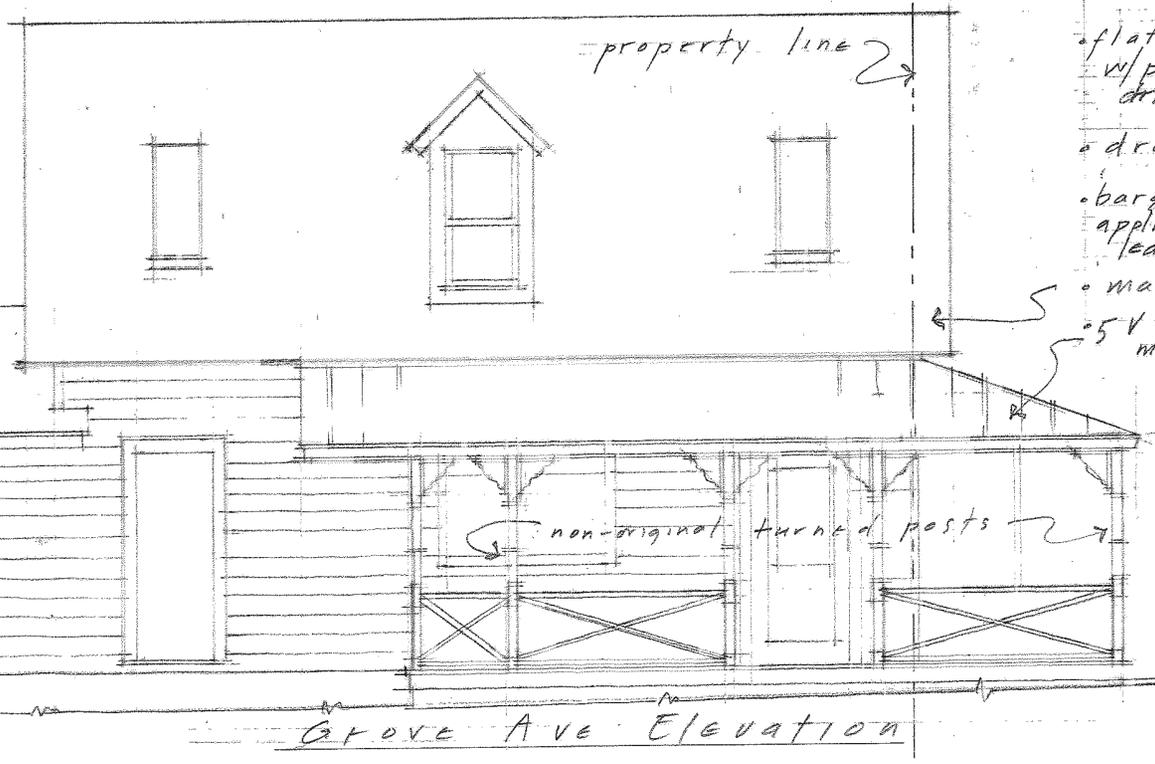
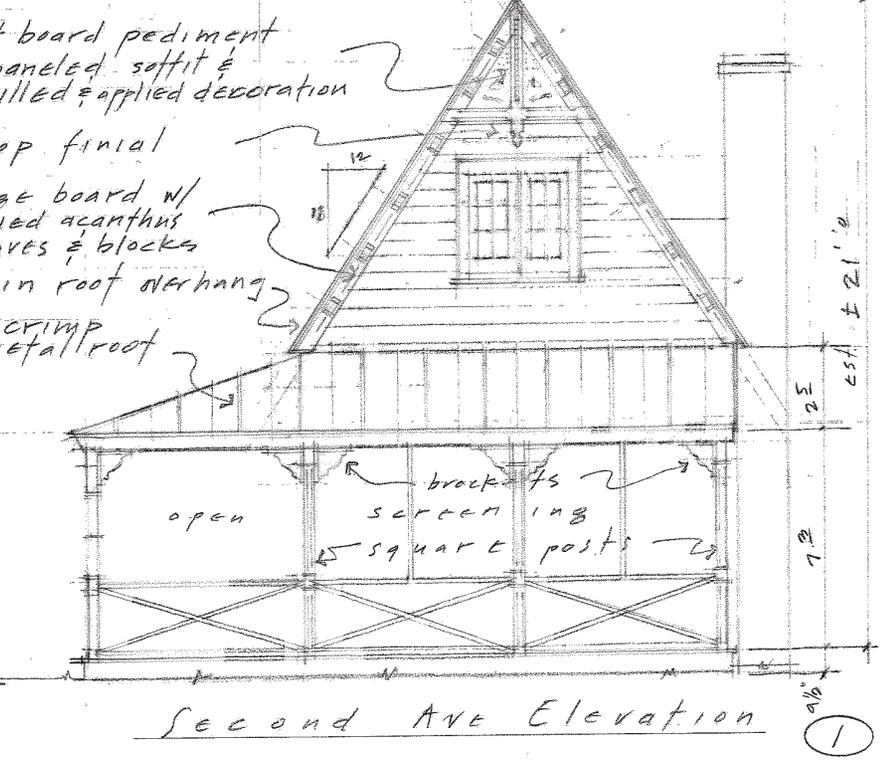
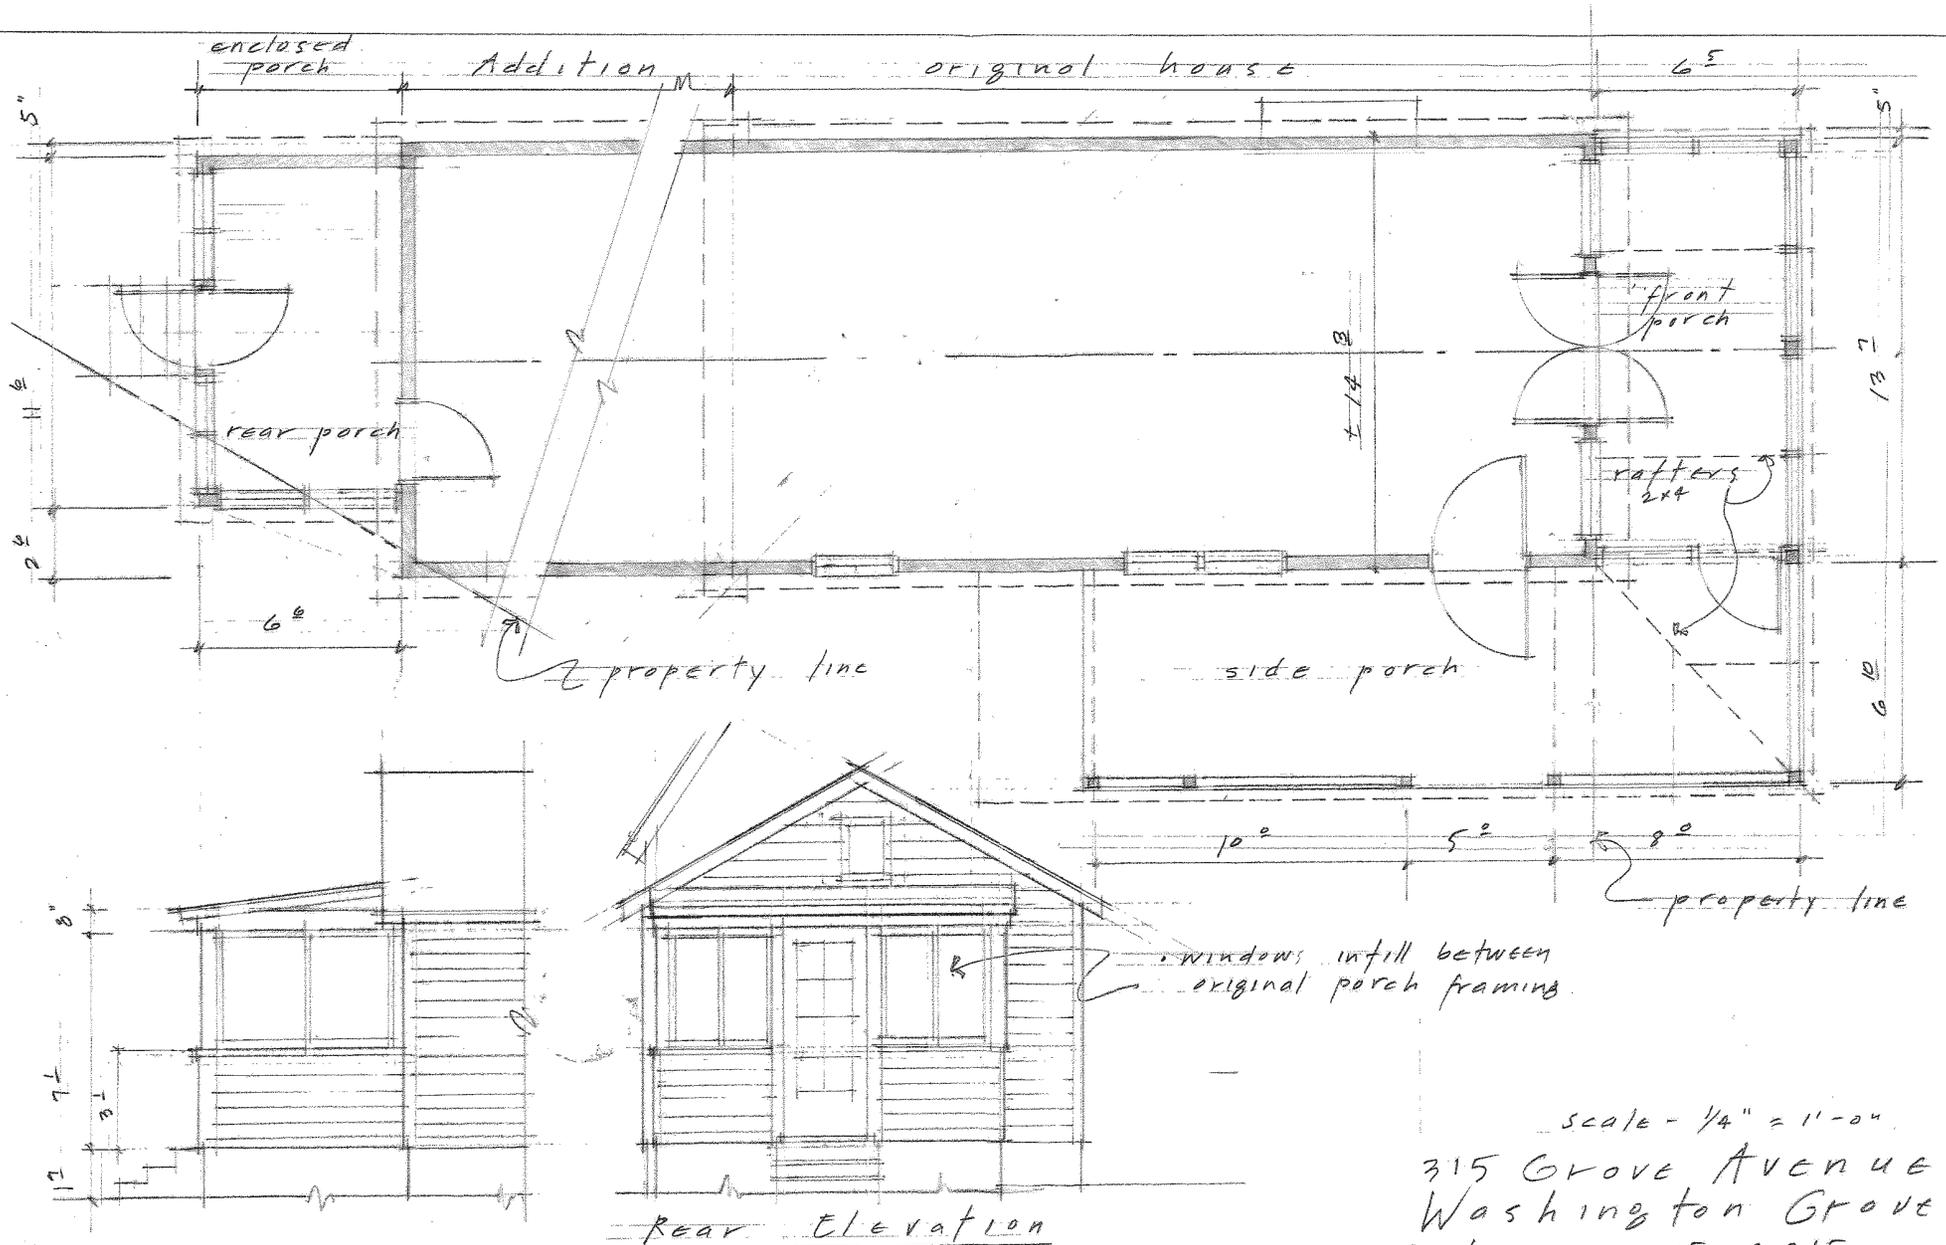
scale - 1/4" = 1'-0"
315 GROVE AVENUE
WASHINGTON GROVE
January 15, 2015

A measured drawing (elevation and plan) and photographs of the section of the **Second Avenue shed porch and attached steeply gabled façade** located on Town property are attached to document the current condition of the structure and its significant Historic Integrity Features.
